SAFETY RECALL

Rear View Camera Image

Reference: 47D / NHTSA 26V-326

Remedy available for
2026 (WS) Grand Wagoneer

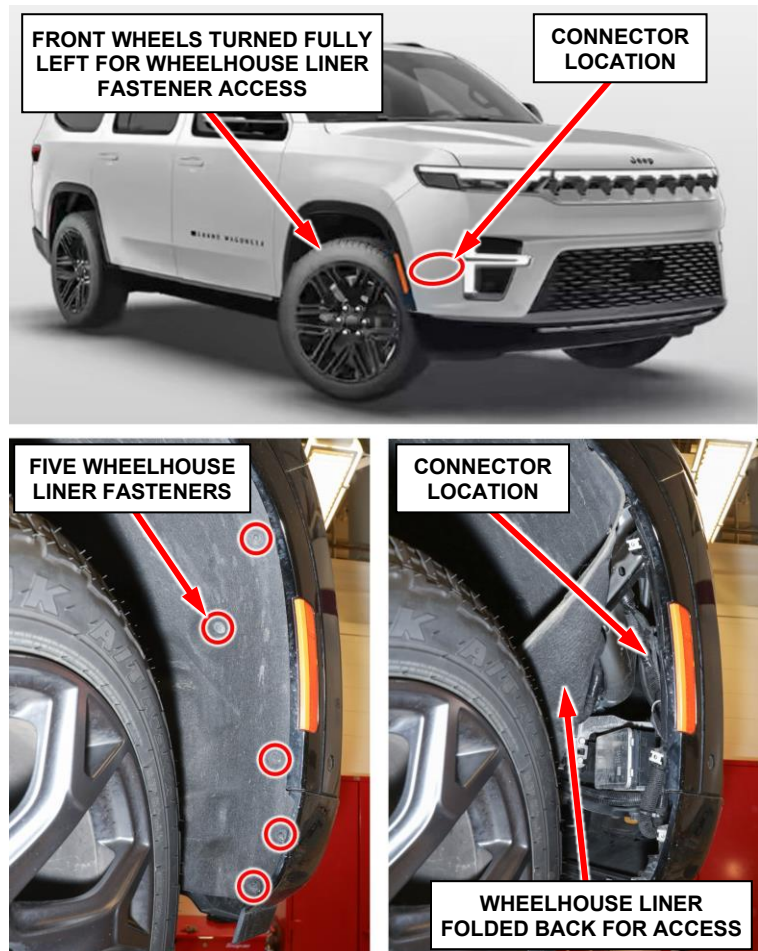
Figure 1 – Camera Harness Connector Location

1. Position the vehicle on a lift, then raise and support the vehicle. **Refer to the detailed service procedures available in DealerCONNECT/ Service Library under: Service Info> 04 - Vehicle Quick Reference / Hoisting / Standard Procedure.**
2. Turn front wheels fully left to access the wheelhouse liner fasteners (Figure 1).
3. On right side of vehicle, remove the five fasteners from the front lower portion of the wheelhouse liner (Figure 1).
4. Fold the front lower portion of the wheelhouse liner back to gain access to the camera wire harness connector (Figure 1).

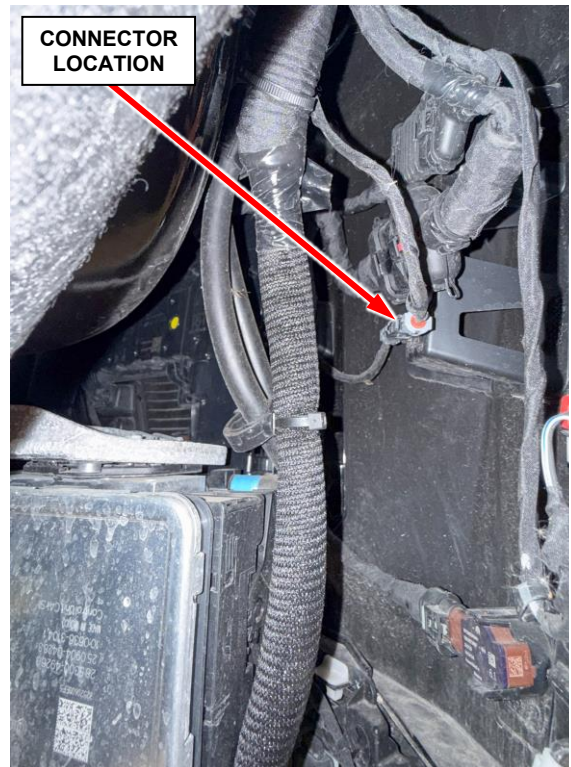
Figure 2 – Camera Harness Connector Location

5. Locate the camera wire harness connector (Figure 2).
6. If the wire harness is disconnected, ensure the connector is clean and dry, then reconnect the harness connector.

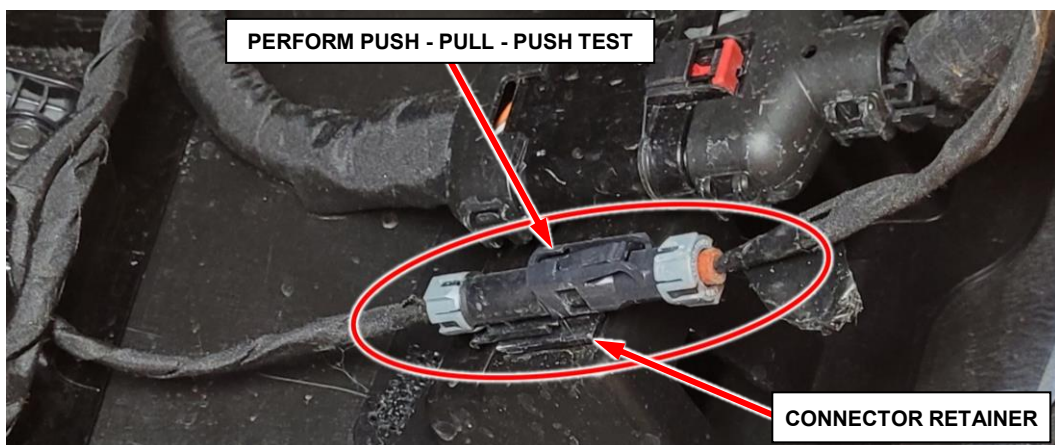
Figure 3 – Ensure Camera Harness Connector Is Securely Attached

7. **All vehicles:** Even if the connector was not previously disconnected. Perform a **Push - Pull - Push** test to ensure the wire harness connector is fully and securely connected (Figure 3).

8. Ensure the wire harness retainer is securely attached (Figure 3).
9. Reinstall the wheelhouse liner (Figure 1).
10. Lower the vehicle then inspect that rearview image appears when vehicle is running and gear selector is placed in reverse.
