## RECALL 26V336 / 2026-255 REMEDY INSTRUCTIONS

## TOURING COIL SUSPENSION SHOCK BOLT REPLACEMENT

| Recall Number | 26E-032 | | |
| Product: | Curt Touring Coil Suspension | | |

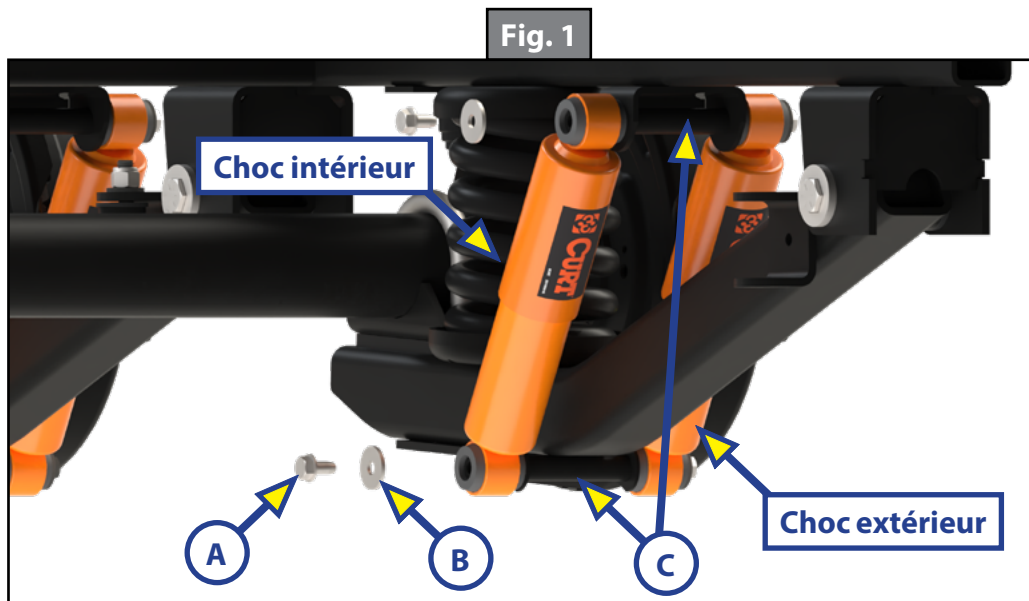
Lippert a identifié des cas où les boulons d'amortisseur de la suspension CURT® Touring Coil (TCS) peuvent avoir été serrés incorrectement lors de l'installation. Bien que nous soyons convaincus qu'il s'agit d'une faible quantité, par mesure de précaution, Lippert émet ce rappel de sécurité afin de remplacer tous les boulons d'amortisseur sur les unités équipées d'une TCS installée en usine sur des châssis Lippert fabriqués avant le 23 avril 2026.

1. En commençant par les amortisseurs intérieurs, desserrer et retirer les deux vis autoformeuses  $\frac{3}{8}$ "-16 x  $\frac{3}{4}$ " existantes (fig. 1A) et les rondelles (fig. 1B) qui fixent chaque amortisseur sur ses goujons (fig. 1C). Conserver les rondelles (PN 249853) pour les réinstaller à l'étape 2.

2. Réinstaller les rondelles retirées sur deux nouveaux boulons à tête hexagonale de grade 8  $\frac{3}{8}$ "-16 x  $\frac{3}{4}$ ".
