Safety Recall: 26V337  
May 2026

## IMPORTANT SAFETY RECALL

Alliance RV has decided that a defect which relates to motor vehicle safety exists in some 2025 thru 2026 Alliance RVs. Units impacted are select Paradigm 5<sup>th</sup> Wheels.

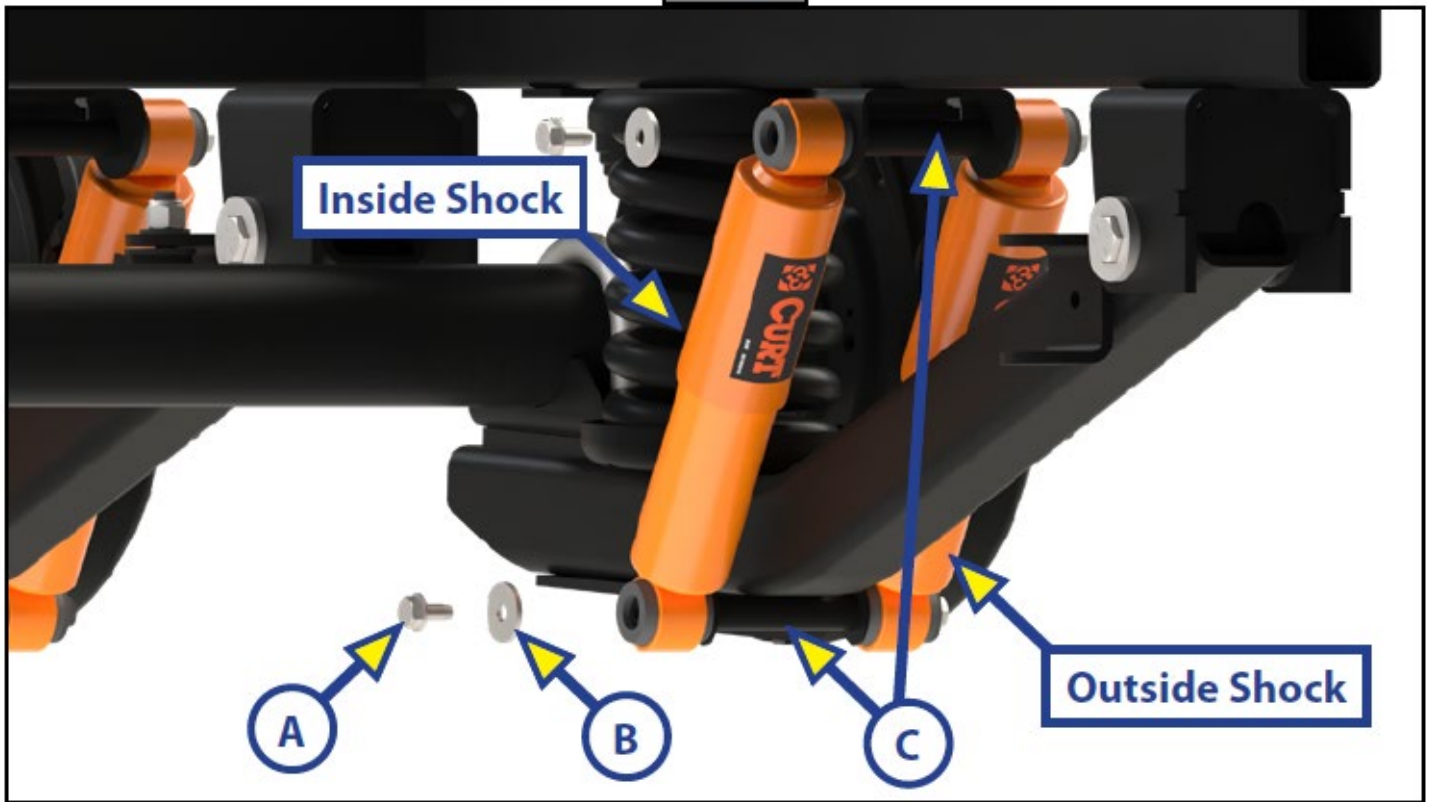
Fig. 1

Alliance RV has determined that certain 2025 – 2026 Paradigm units equipped with CURT Touring Coil Suspension systems may contain shock retaining bolts that were improperly tightened during production of the suspension assembly. Under certain operating conditions, the retaining bolt head may fracture which could allow the retaining washer and/or bolt head to detach from the vehicle and become road debris, increasing the risk of a crash.

1. Starting with the inside shocks, loosen and remove the two existing 3/8"-16 x 3/4" thread forming screws (Fig. 1A) and washers (Fig. 1B) securing each shock absorber onto its posts (Fig. 1C). Retain washers (PN 249853) for reinstallation in Step 2.

2. Reinstall previously-removed washers onto two new 3/8" - 16 x 3/4" Grade 8 hex head bolts.
