Safety Recall: 26V337  
May 2026

## IMPORTANT SAFETY RECALL

Alliance RV has decided that a defect which relates to motor vehicle safety exists in some 2025 thru 2027 Alliance RVs. Units impacted are select Paradigm 5<sup>th</sup> Wheels.

## \*\*\*Product Safety Notice\*\*\*

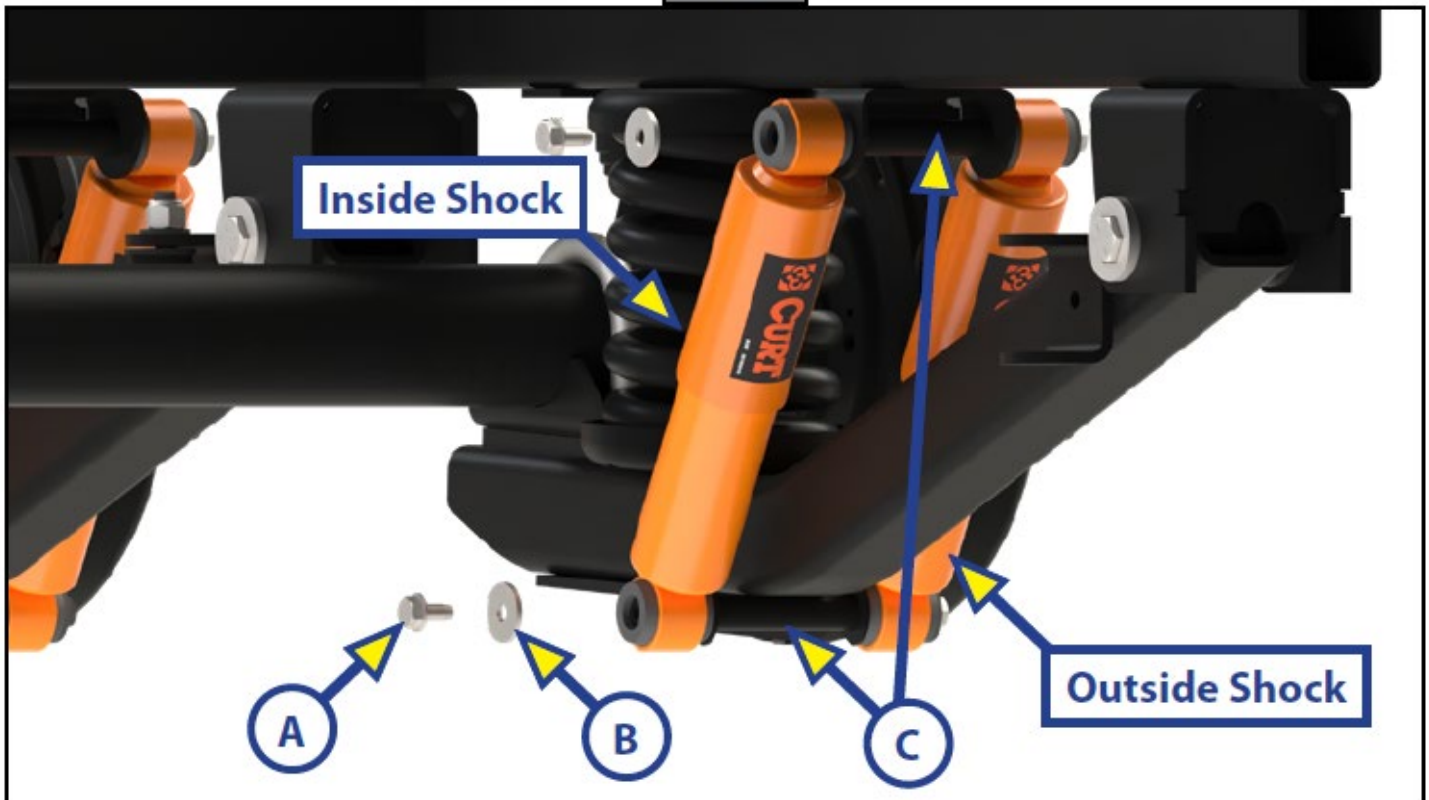
Fig. 1

Alliance RV has determined that certain 2025 – 2027 Paradigm units equipped with CURT Touring Coil Suspension systems may contain shock retaining bolts that were improperly tightened during production of the suspension assembly. Under certain operating conditions, the retaining bolt head may fracture which could allow the retaining washer and/or bolt head to detach from the vehicle and become road debris, increasing the risk of a crash.

1. Starting with the inside shocks, loosen and remove the two existing 3/8"-16 x 3/4" thread forming screws (Fig. 1A) and washers (Fig. 1B) securing each shock absorber onto its posts (Fig. 1C). Retain washers (PN 249853) for reinstallation in Step 2.

2. Reinstall previously-removed washers onto two new 3/8" - 16 x 3/4" Grade 8 hex head bolts.

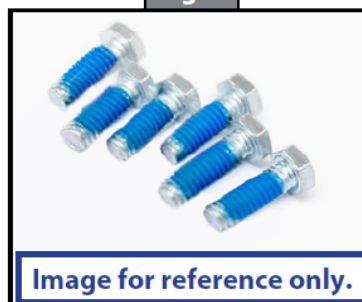
Fig. 2

**NOTE:** Some kits will come with bolts pre-coated with thread locker instead of 0.02oz capsules of Loctite. If the bolts are pre-coated (Fig.2), skip step 3.

3. Apply two threads of thread locker to the Grade 8 bolt threads (Fig 2).
4. Install new bolt assemblies by hand for a minimum of three full threads (or three turns) before proceeding to step 5.
5. Torque new Grade 8 bolts to 20-30 ft-lbs. Do not over torque bolts.
6. Repeat procedure on all other inside and outside shock absorber bolts.
