## PRODUCT CAMPAIGN BULLETIN

**APPLICABILITY:** 2026MY Forester

**NUMBER:** WRF-26R

**SUBJECT:** Safety Recall and Stop Sale: Forester  
Power Moonroof Glass Adhesion

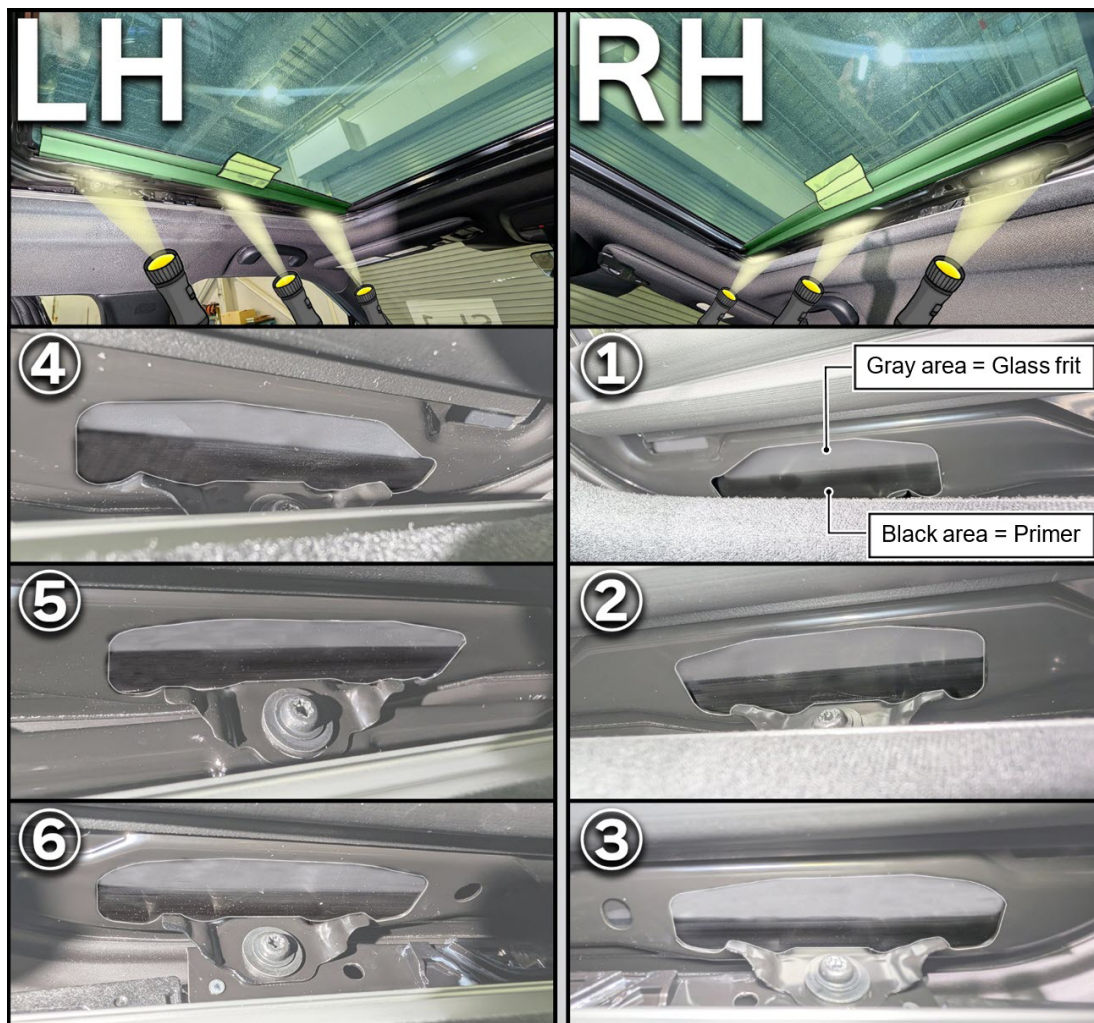
1.4 Using a flashlight to illuminate the bracket, visually inspect all six mounting brackets shown in the diagram below. Ensure that all brackets have both black primer and grey glass frit. If only grey frit is found on any of the brackets, proceed to Step 2 (sunroof assembly replacement). If both primer and grey frits are present on all six brackets, reinstall the lower lid covers. The procedure is complete.

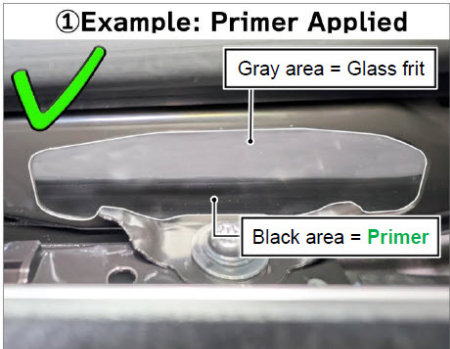
| JUDGEMENT CRITERIA | |
|---|---|
| <p>①Example: Primer Applied</p> <p>②Example: Primer Applied</p> | <p>Example: No Primer Applied</p> |
| <b>OK</b> | If any primer is found at all 6 location on the lid assembly-sunroof it is acceptable, reinstall the lid covers. This completes the procedure. |

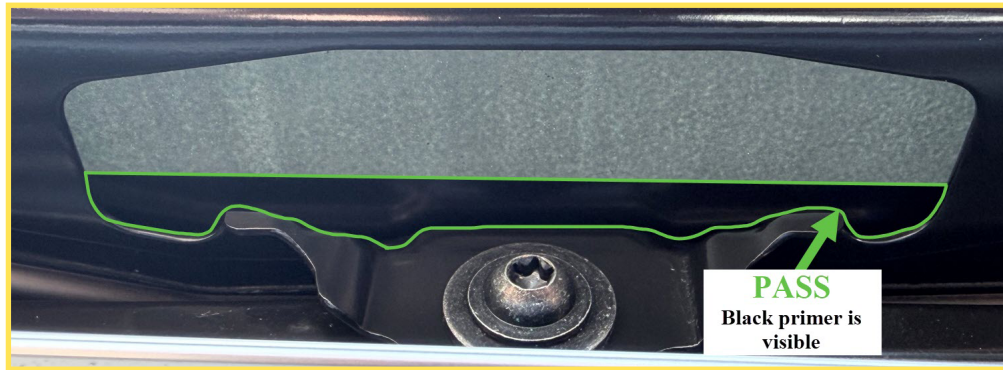
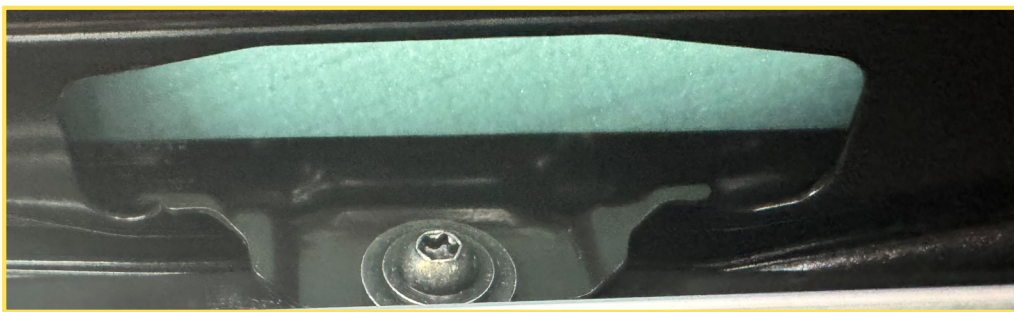
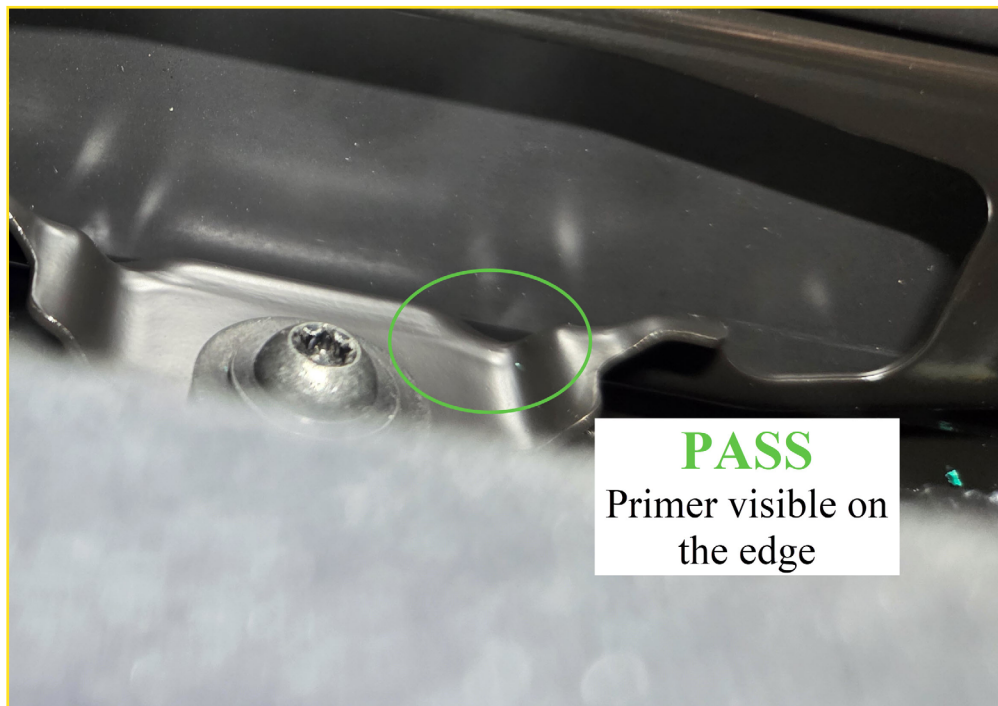
Additional examples of acceptable primer application on the sunroof lid assembly.

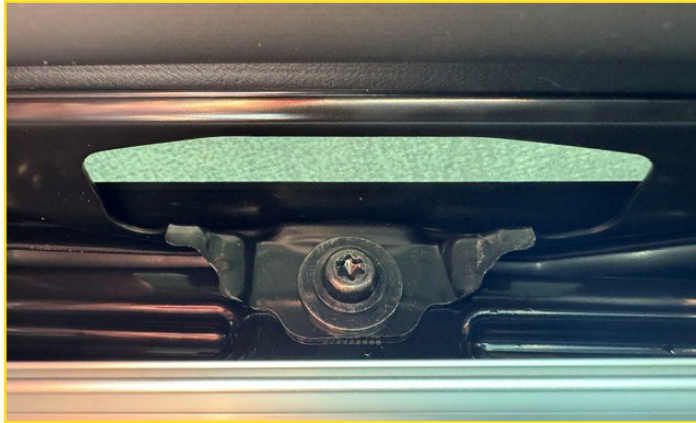
This image was taken outdoors in sunlight with no additional lighting.

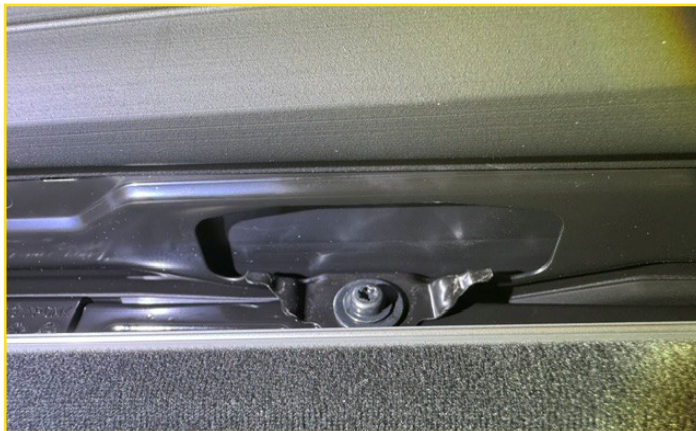
This image was taken indoors with a flashlight positioned inside the vehicle.

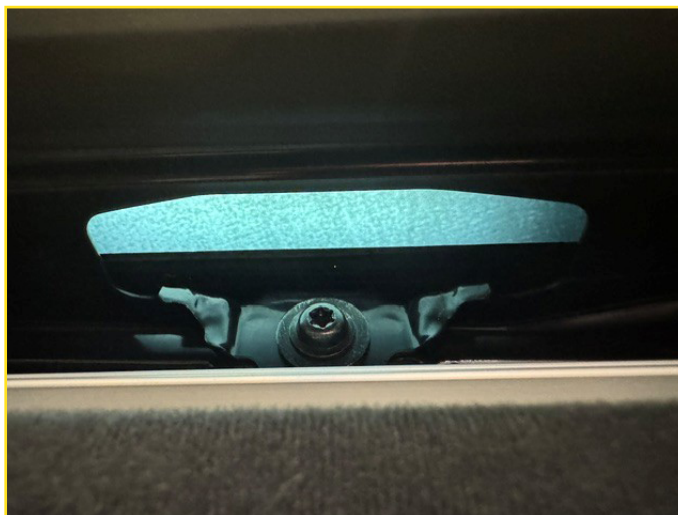
This image was taken indoors with a flashlight positioned outside the vehicle aimed toward the opposite side of the glass.

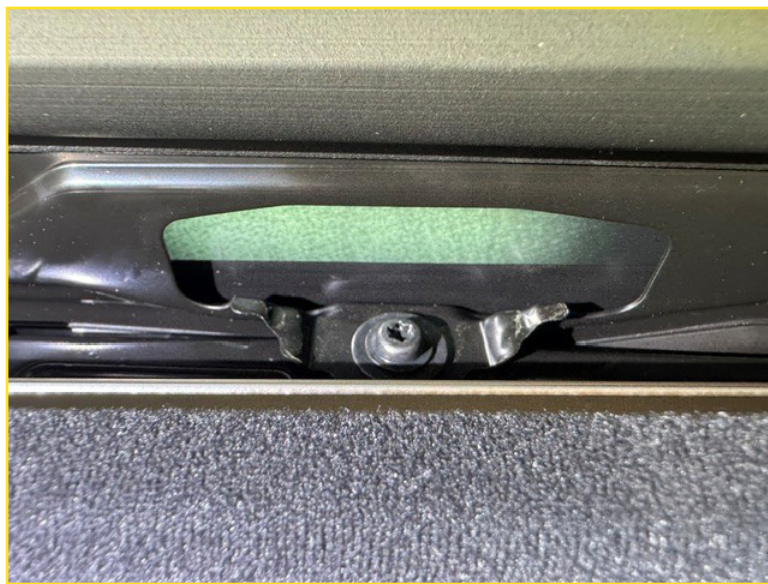
This image was taken indoors with a flashlight positioned outside the vehicle aimed toward the opposite side of the glass and an additional flashlight positioned inside the vehicle.
