## PRODUCT CAMPAIGN BULLETIN

**APPLICABILITY:** 2026MY Forester

**NUMBER:** WRF-26R

**SUBJECT:** Safety Recall and Stop Sale: Forester  
Power Moonroof Glass Adhesion

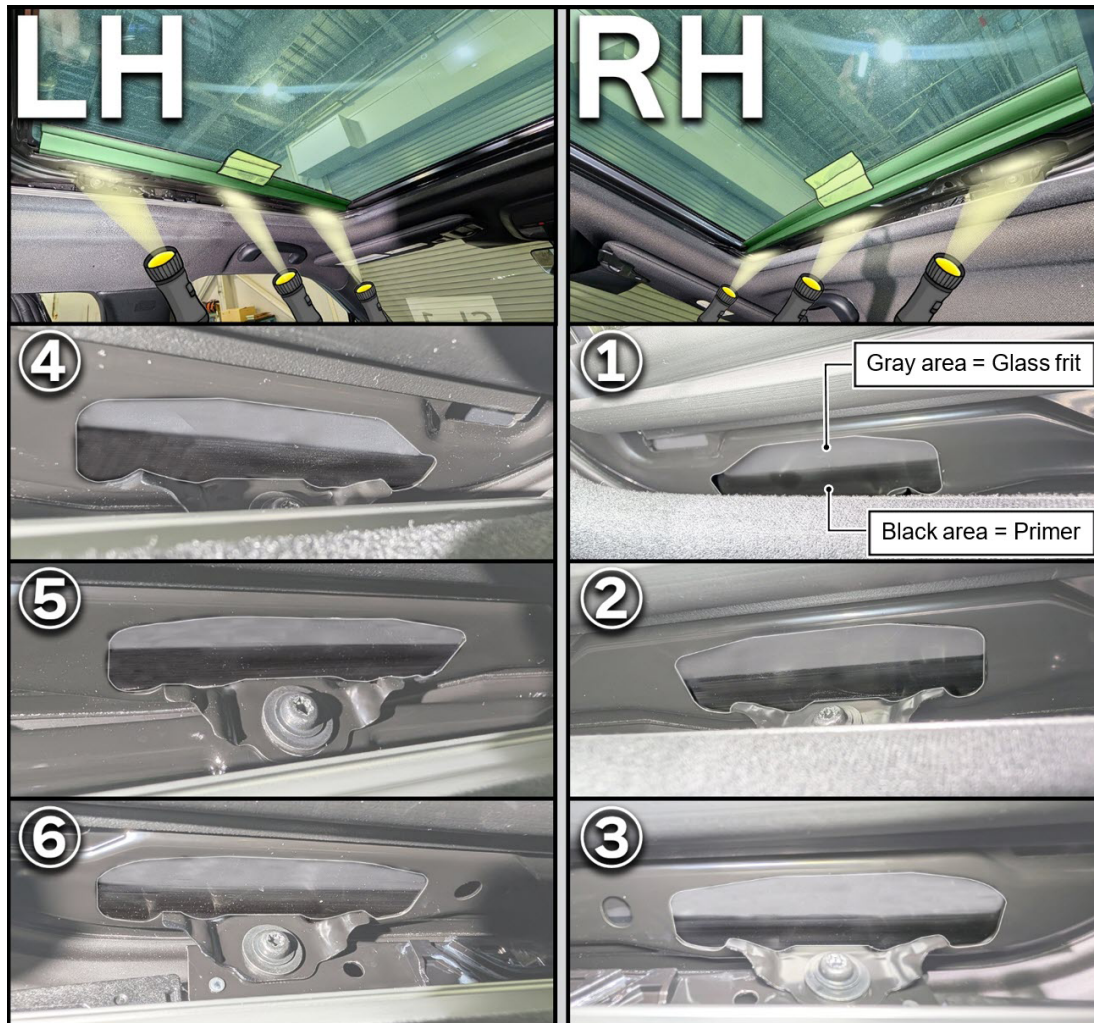
1.4 Using a flashlight to illuminate the bracket, visually inspect all six mounting brackets shown in the diagram below. Ensure that all brackets have both black primer and grey glass frit. If only grey frit is found on any of the brackets, take clear photos of the affected mounting bracket(s) and submit an NQR. Wait for approval prior to proceeding to Step 2 (sunroof assembly replacement). If both primer and grey frits are present on all six brackets, reinstall the lower lid covers. The procedure is complete.

Note: For improved visibility, shine a bright light from outside through the glass or perform the inspection outdoors in direct sunlight. Attaching protective tape to the inside of the glass at the bracket location helps focus the light on the bracket.

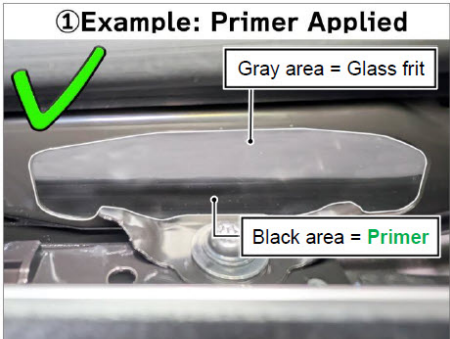
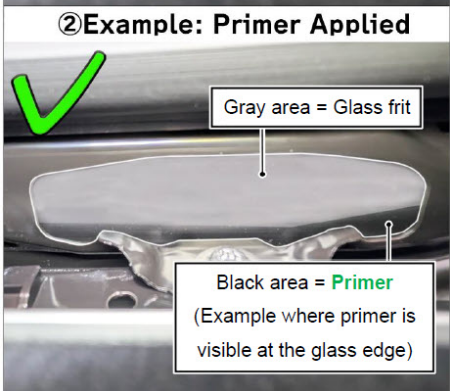
| JUDGEMENT CRITERIA | |
|---|---|
| <p>①Example: Primer Applied</p> <p>②Example: Primer Applied</p> | <p>Example: No Primer Applied</p> |
| <b>OK</b> | If any primer is found at all 6 location on the lid assembly-sunroof it is acceptable, reinstall the lid covers. This completes the procedure. |

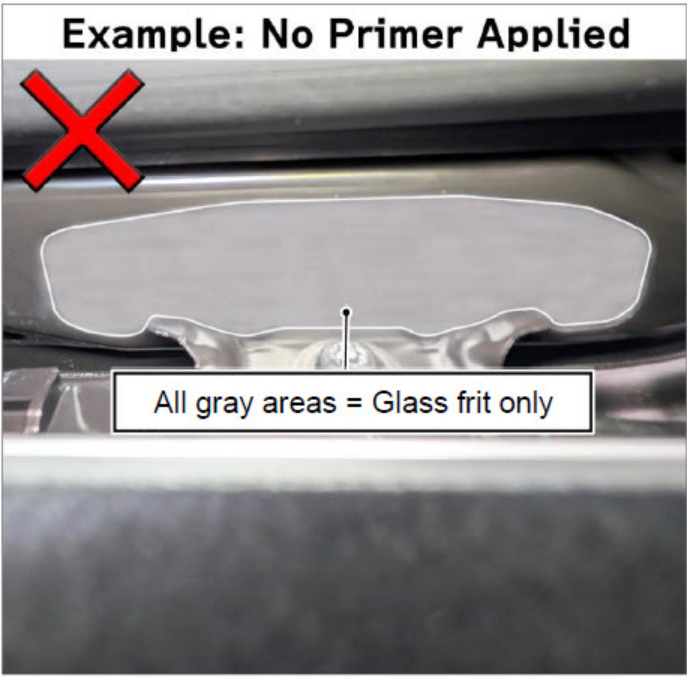
| JUDGEMENT CRITERIA | |
|---|---|
| <b>NG</b> | If primer is not applied to one or more of the six inspection locations, the part is considered defective. Proceed to step 2. |

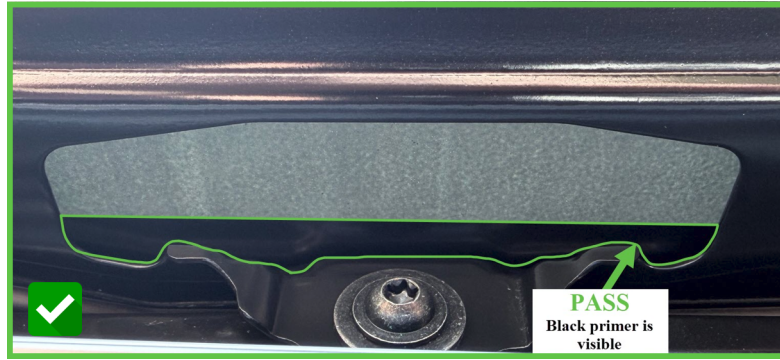
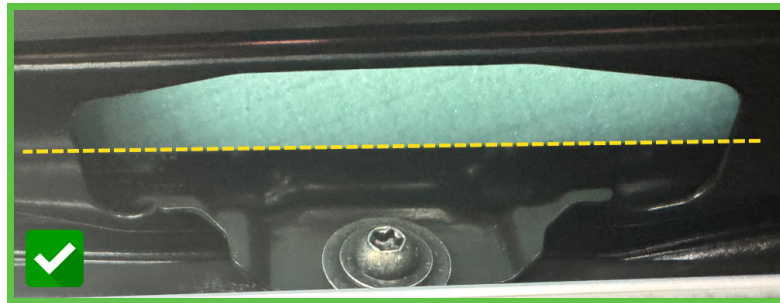
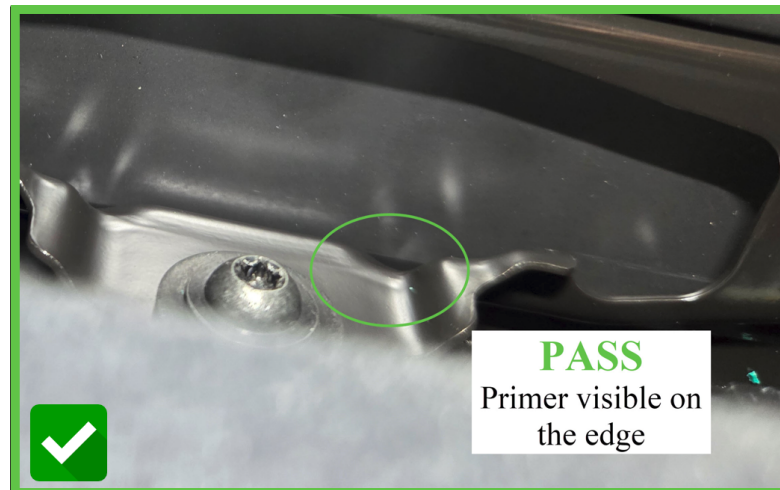
Additional examples of acceptable primer application on the sunroof lid assembly.

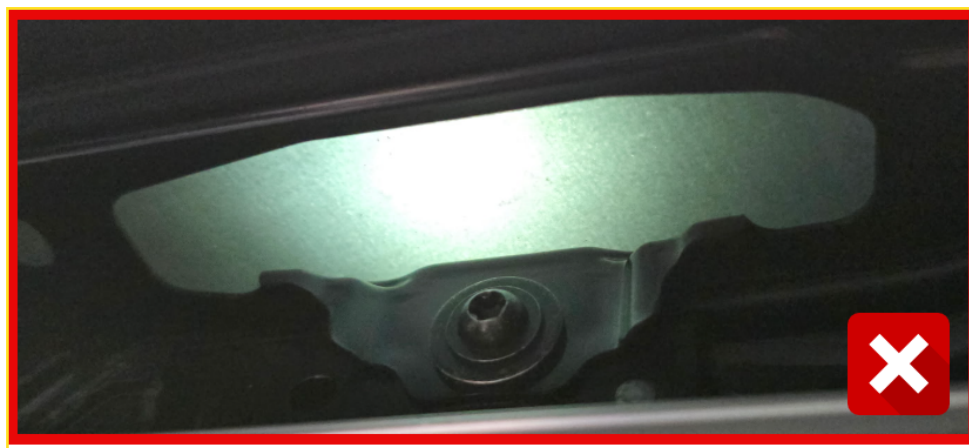
The image below is an example of a sunroof glass lid with no primer applied. This example required replacement.

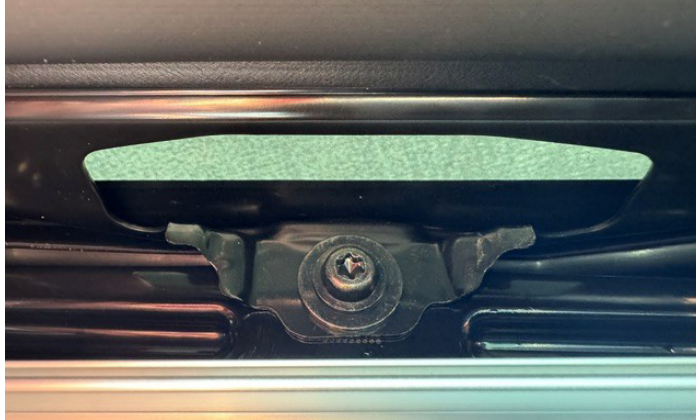
This image was taken outdoors in sunlight with no additional lighting.

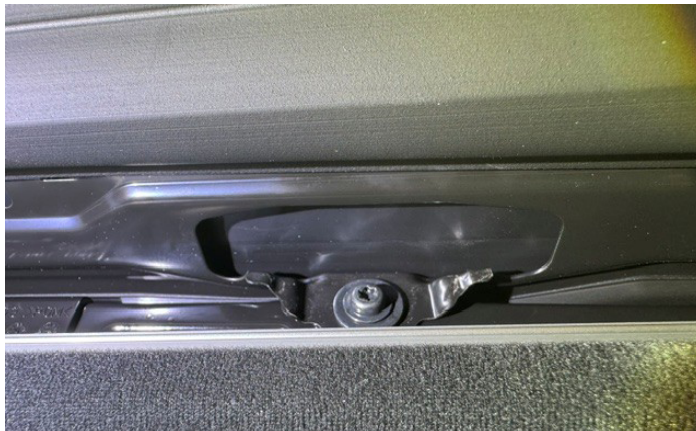
This image was taken indoors with a flashlight positioned inside the vehicle.

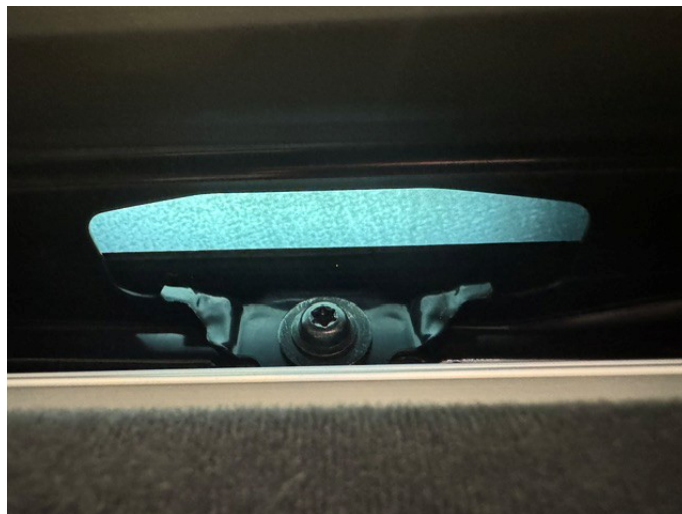
This image was taken indoors with a flashlight positioned outside the vehicle aimed toward the opposite side of the glass.

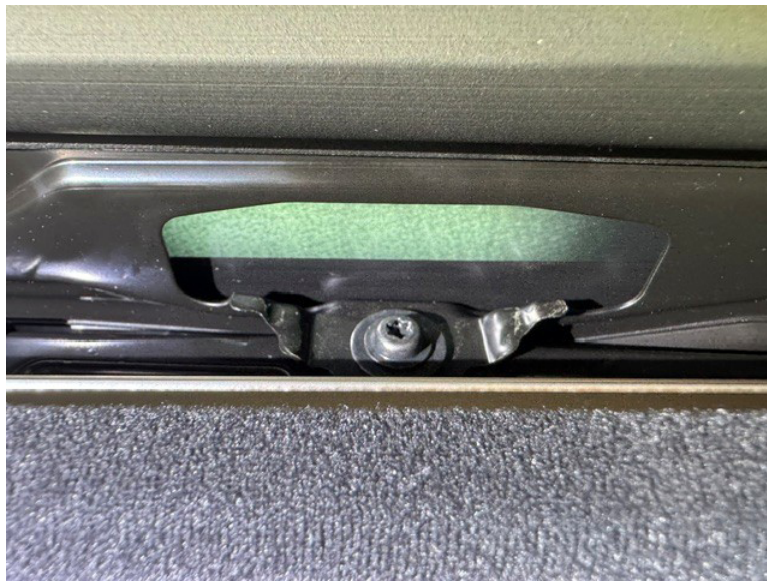
This image was taken indoors with a flashlight positioned outside the vehicle aimed toward the opposite side of the glass and an additional flashlight positioned inside the vehicle.
