## PRODUCT CAMPAIGN BULLETIN

**APPLICABILITY:** 2026MY Forester

**NUMBER:** WRF-26

**SUBJECT:** Safety Recall and Stop Sale: Forester  
Power Moonroof Glass Adhesion

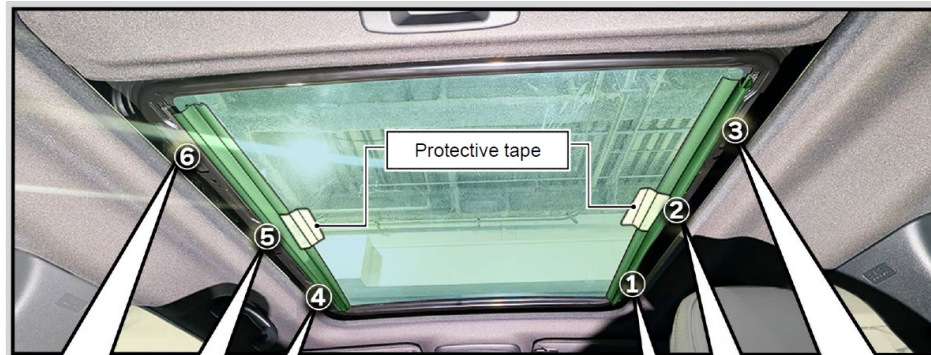
1.4 Visually inspect all six mounting brackets shown in the diagram below. Inspect to ensure all brackets have black primer and grey glass frit. If only grey frits are found on any of the brackets, proceed to step 2, sunroof assembly replacement. If primer and grey frits are found on all 6 brackets, reinstall the lower lid covers, and the procedure is complete.

| JUDGEMENT CRITERIA | |
|---|---|
| NG | If primer is not applied to one or more of the six inspection locations, the part is considered defective. Proceed to step 2. |

1.3 Temporarily secure the lid covers to the glass with protective tape.
