## PRODUCT CAMPAIGN BULLETIN

**APPLICABILITY:** 2026MY Forester

**NUMBER:** WRF-26R

**SUBJECT:** Safety Recall and Stop Sale: Forester  
Power Moonroof Glass Adhesion

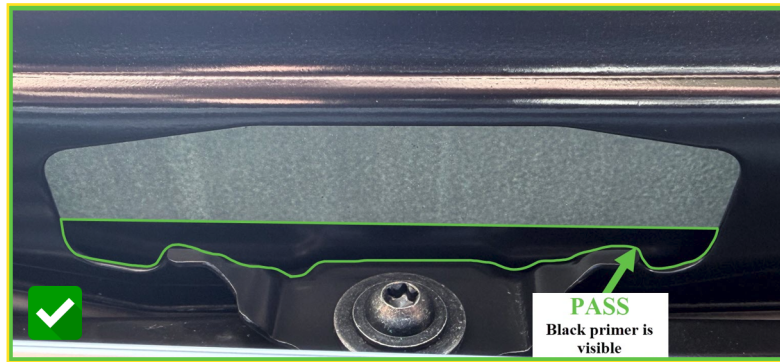
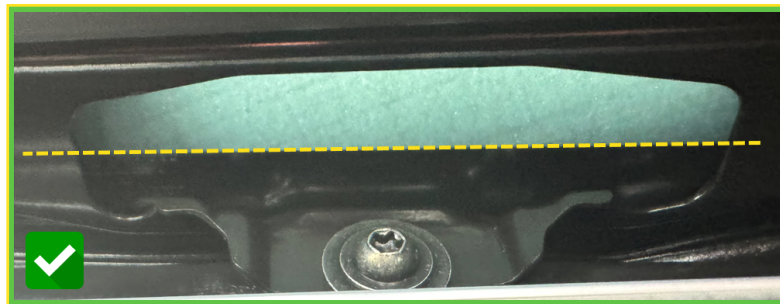
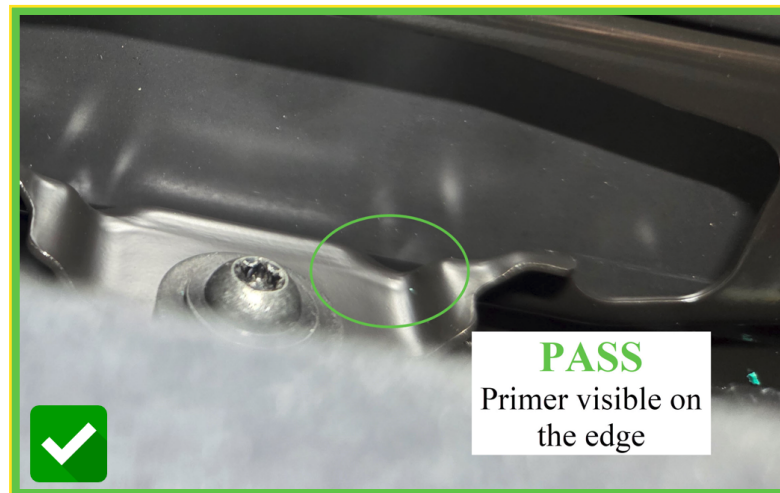
Additional examples of acceptable primer application on the sunroof lid assembly.

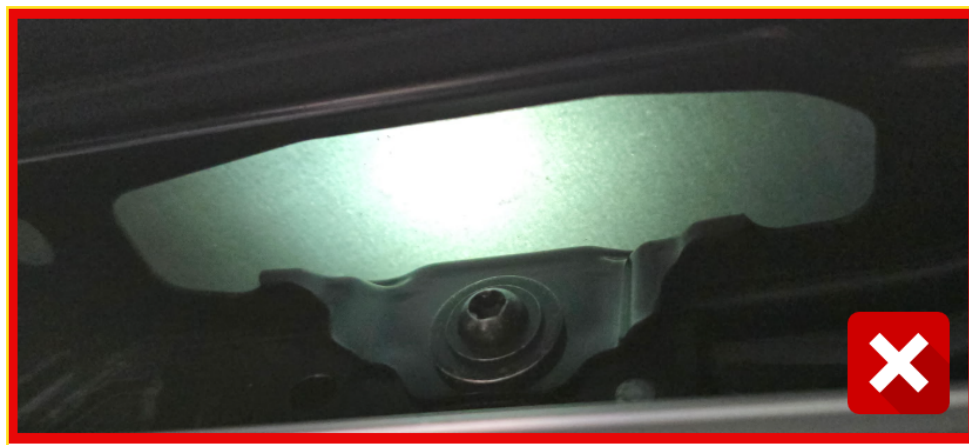
The image below is an example of a sunroof glass lid with no primer applied. This example required replacement.

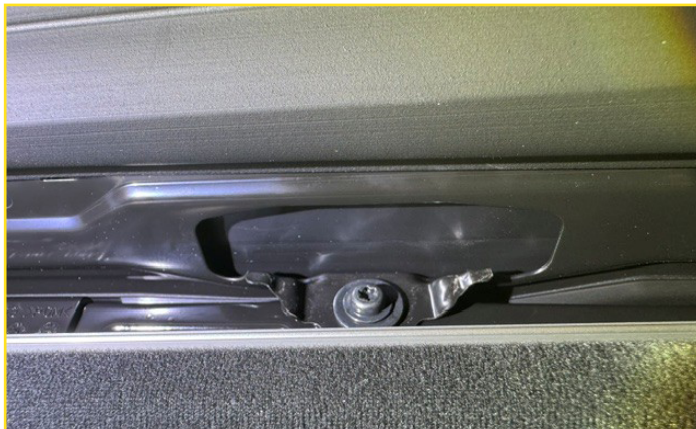
This image was taken indoors with a flashlight positioned inside the vehicle.
