Safety Recall

Mack Trucks Inc.
Greensboro, NC USA

Date	Number	Release	Page
05.2026	SC0495	03	1(5)

Wheel Mounting Interference AN, AN(4), GR, PI, PR(4)

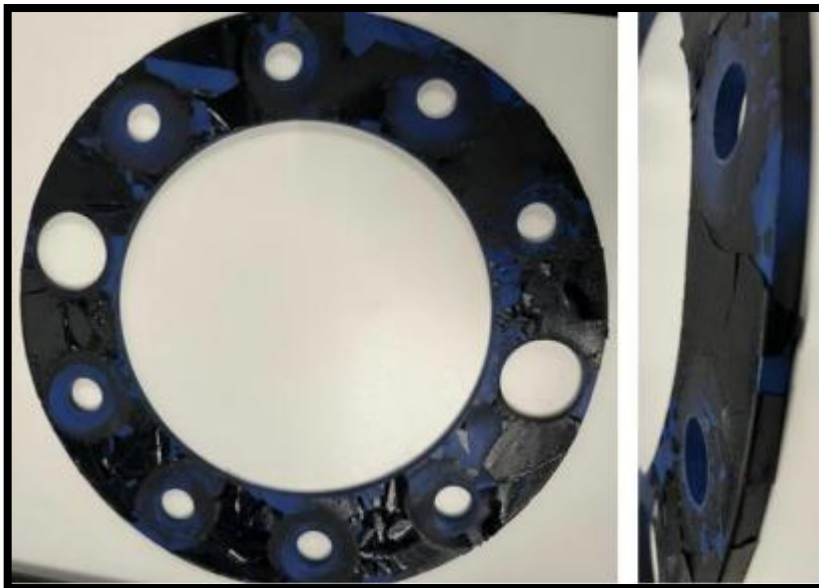
3. Raise wheel end.
4. Remove lug nuts and remove wheel.
5. Inspect for paint masking ring on all axles. Please note that masking ring may be painted with black axle paint as shown.

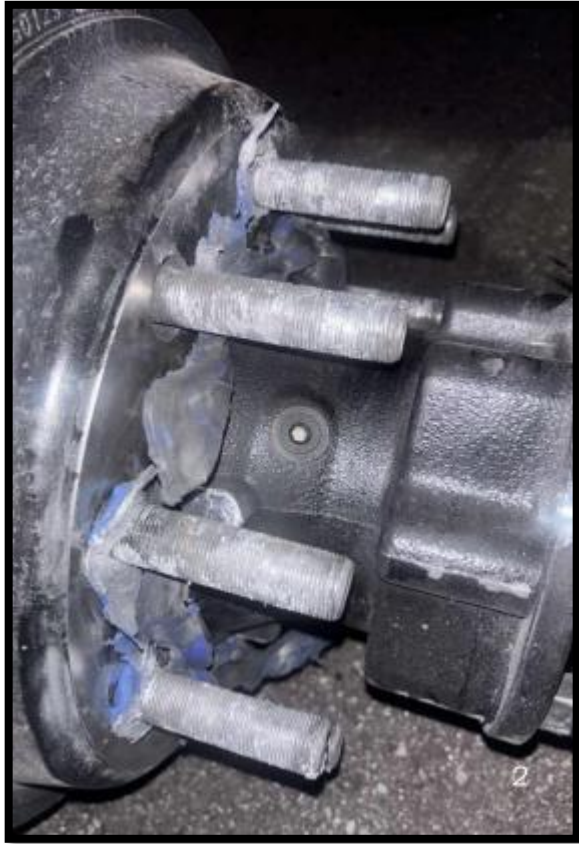
6. IF MASKING RING IS PRESENT:

- A. Remove all foreign material, if the vehicle has brake drums, remove drums and verify joints are free of debris.
- B. Inspect hub, studs, drums, and wheels for damage and replace if necessary.
- C. Reinstall wheel and secure lug nuts using standard tightening procedures.

Tightening Specifications
644±34 Nm (475±25 lb-ft)
