# ***SERVICE PROCEDURE***

**26509  
July 2026**

**SUBJECT: SAFETY RECALL**

**Brake timing in certain 2026 and 2027  
International® HV™ Series trucks built 07/01/2025  
thru 04/16/2026 with the following unique  
configurations (feature codes):**

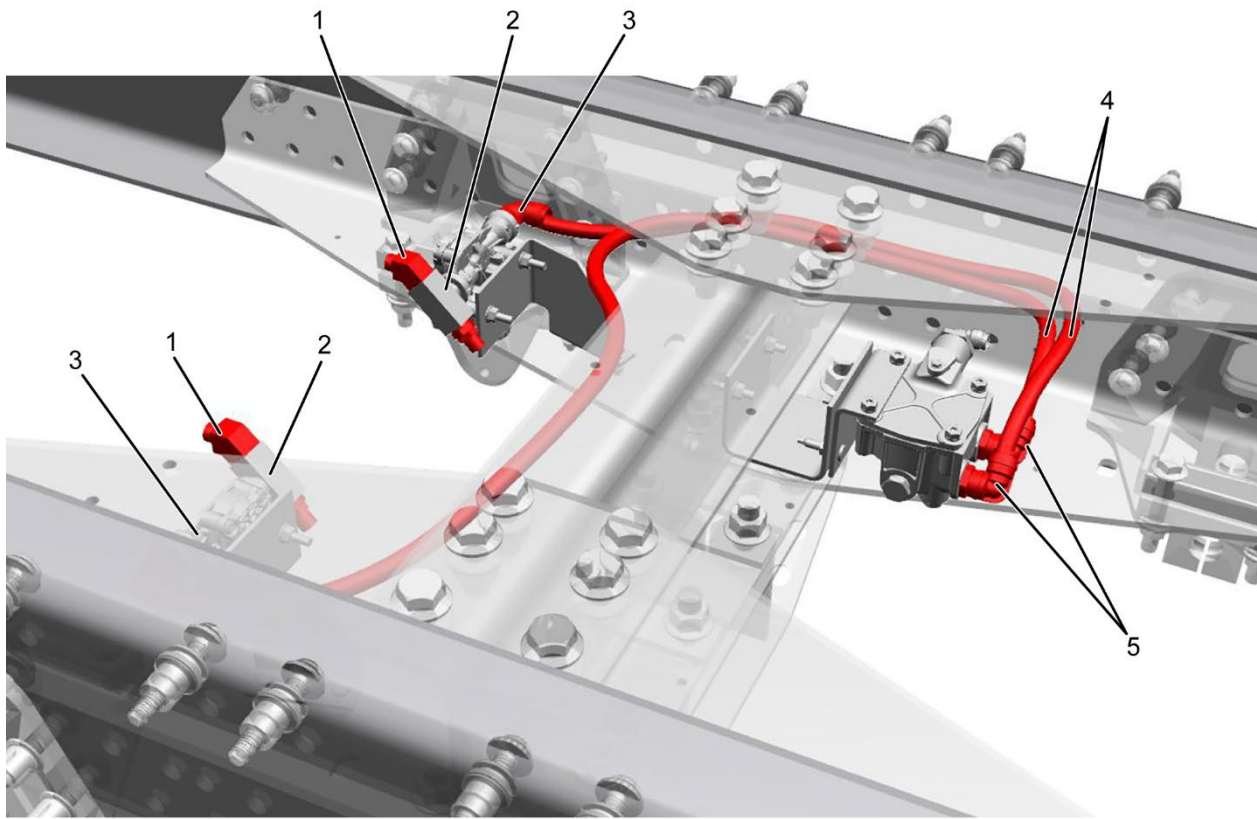
### Figure 1. Fitting Locations

1. 45-degree fitting for rear rear brake chambers (2)
2. Tee fitting on modulator valve (2)
3. 90-degree fitting at modulator valves (2)
4. Air line from relay valve to modulator valve (2)
5. 90-degree fitting on relay valve (2)

6. Starting on the driver-side, remove the 5/8-inch air line from the relay valve to the modulator valve (Figure 1, Item 4).
7. At the relay valve, remove the 5/8-inch 90-degree elbow and install the 3/4-inch 90-degree elbow. (Figure 1, Item 5).
8. At the modulator valve, remove the 5/8-inch 90-degree elbow and install the 3/4-inch 90-degree elbow. (Figure 1, Item 3).

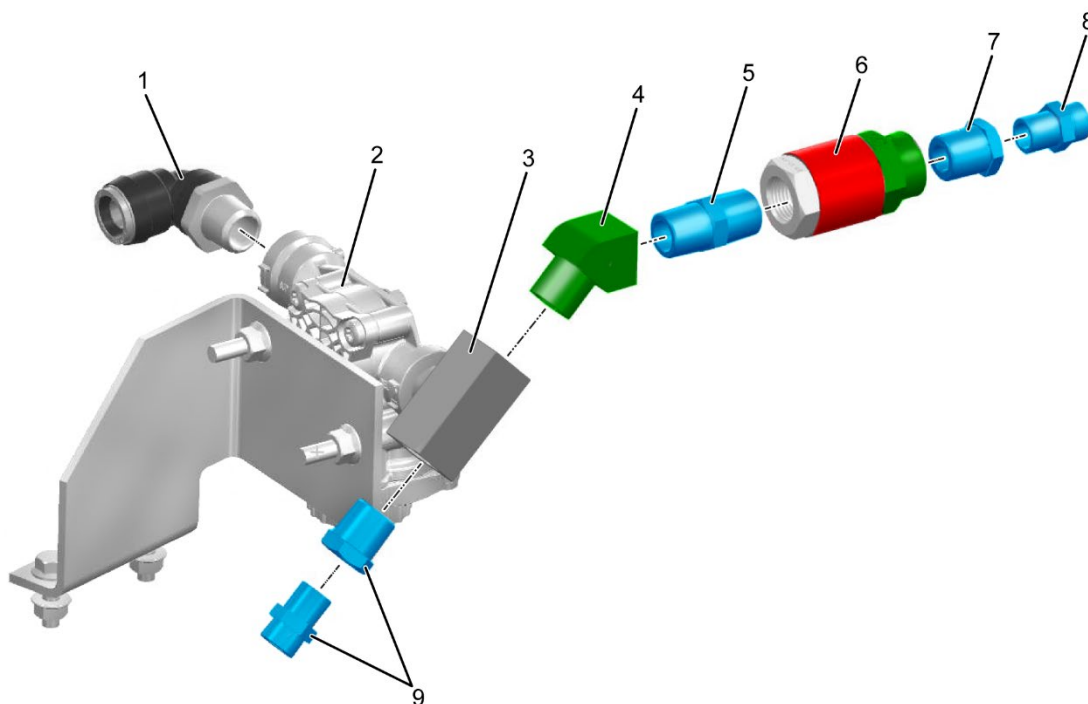
**Figure 2. Modulator Valve with Quick Release Valve Installed**

1. 90-degree elbow installed in Step 8 (2017520C1)
2. Modulator valve
3. Tee fitting
4. Elbow (444058)
5. Nipple (443982)
6. Quick release valve (3548736C1)
7. Reducer bushing (444034)
8. Adapter (3572104C1)
9. Fitting for forward rear axle (2 shown)

12. Starting on the driver-side, remove the air hose going to the rear rear brake chamber from the 45-degree fitting at the modulator valve (Figure 2, Item 2).

13. Note the angle of the 45-degree fitting and using a backup wrench, remove the 45-degree fitting from the tee fitting (Figure 2, Item 3).
14. Using a backup wrench in the same orientation notated in Step 13, install and tighten new elbow (Figure 2, Item 4) into tee fitting (Figure 1, Item 3) on modulator valve (Figure 2, Item 2).

15. Install and tighten nipple (Figure 2, Item 5) into elbow (Figure 2, Item 4).
16. Install and tighten quick release valve (Figure 2, Item 6) into nipple (Figure 2, Item 5) with air pointing toward the rear rear brake chamber hose.

17. Install and tighten reducer bushing (Figure 2, Item 7) into the quick release valve (Figure 2, Item 6).
18. Install adapter (Figure 2, Item 8) in recently installed reducer bushing (Figure 2, Item 7).

19. Install and tighten air hose that was removed in Step 13 into the adapter (Figure 2, Item 8).
20. Repeat Steps 12 through 19 on passenger-side.
21. In the cab, release the parking brake and check for air leaks at hoses and fittings just installed. Repair any leaks if found.
