**TECHNICAL INSTRUCTIONS**  
**FOR**  
**SAFETY RECALL 26LA07**  
**REPROGRAMMING FOR**  
**BATTERY ECU**

**CERTAIN 2026 RZ**

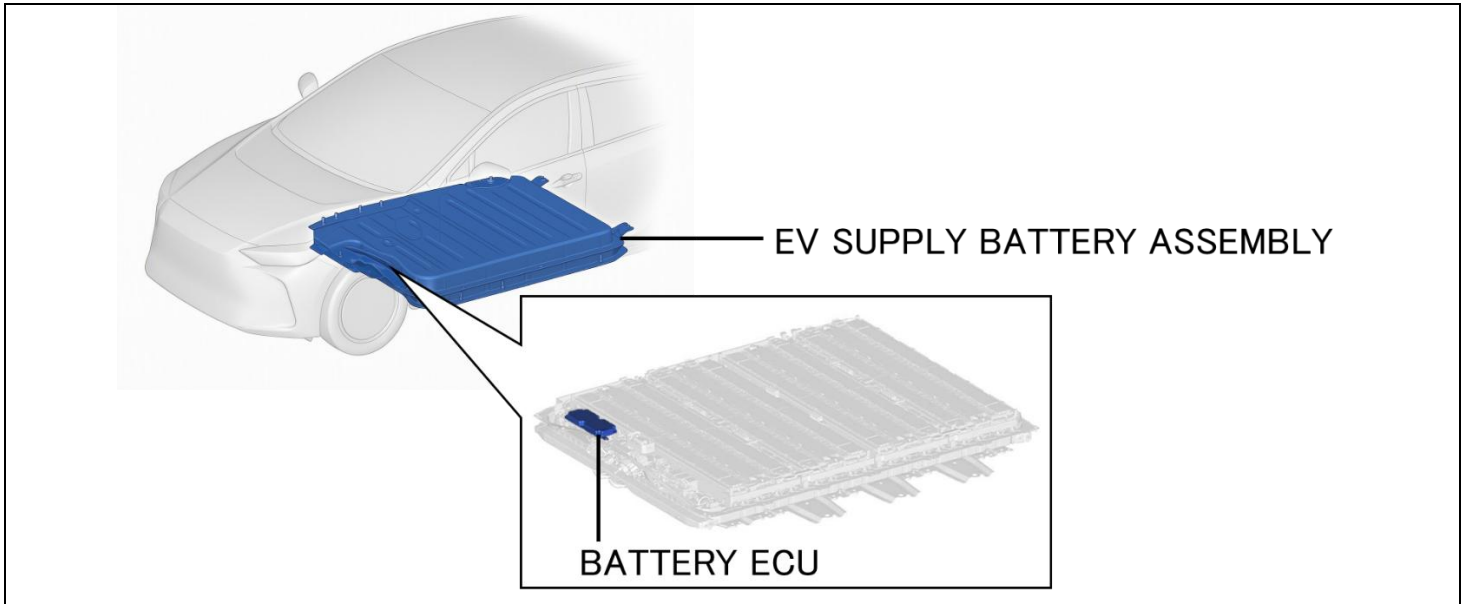
The ECU for the battery supplying electricity to the drivetrain in the subject vehicles can experience an error that can cause the electric drive system to shut down. While power steering and power-assisted braking continue to operate, this can cause a loss of motive power while driving at a higher speed, increasing the risk of a crash.
