**TECHNICAL INSTRUCTIONS**  
**FOR**  
**SAFETY RECALL 26TA11**  
**REPROGRAMMING FOR**  
**BATTERY ECU**

**CERTAIN 2026 bZ**

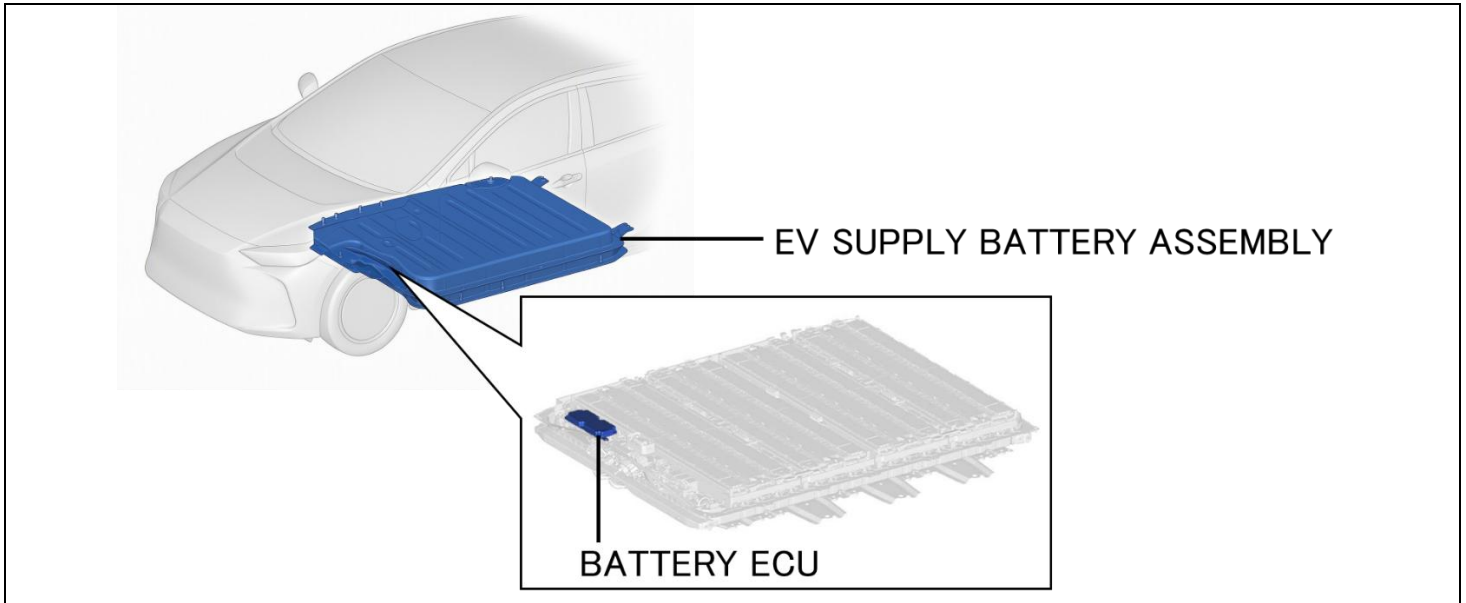
The ECU for the battery supplying electricity to the drivetrain in the subject vehicles can experience an error that can cause the electric drive system to shut down. While power steering and power-assisted braking continue to operate, this can cause a loss of motive power while driving at a higher speed, increasing the risk of a crash.

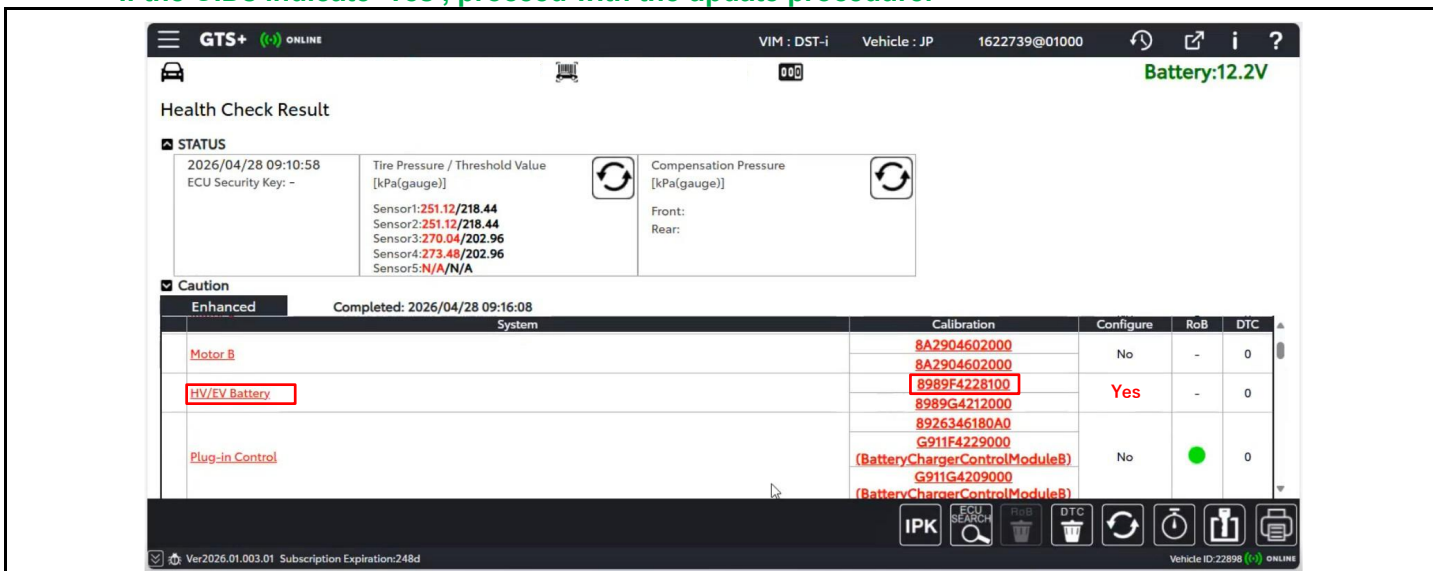
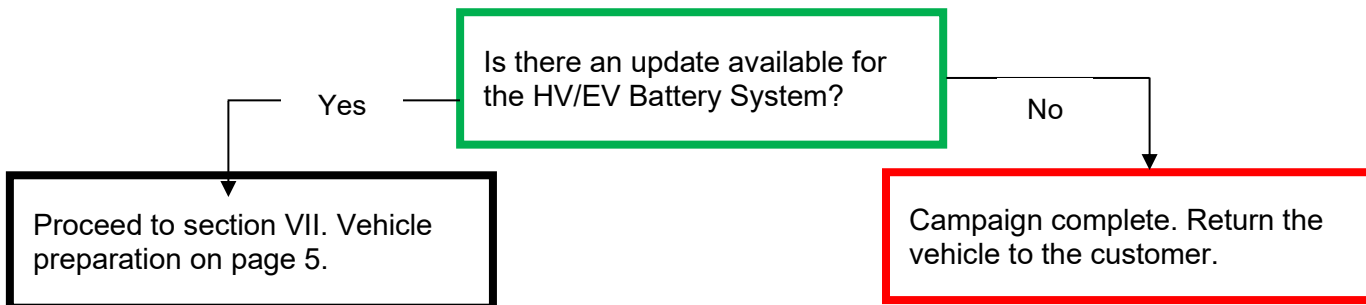
- Locate the "Update" column of the "Calibration Information" for the HV/EV Battery system on the "Health Check Result" screen.
- Determine the status of an available update; indicated by YES or NO.

If the CIDs indicate 'Yes', proceed with the update procedure.
