# VOLUNTARY RECALL CAMPAIGN

| FA26-003 | NTB26-039 | June 29, 2026 |

## VOLUNTARY SAFETY RECALL CAMPAIGN 2025 SENTRA; FRONT LH DRIVE SHAFT

**CAMPAIGN ID #:** PMA68  
**APPLIED VEHICLES:** 2025 Sentra (B18)

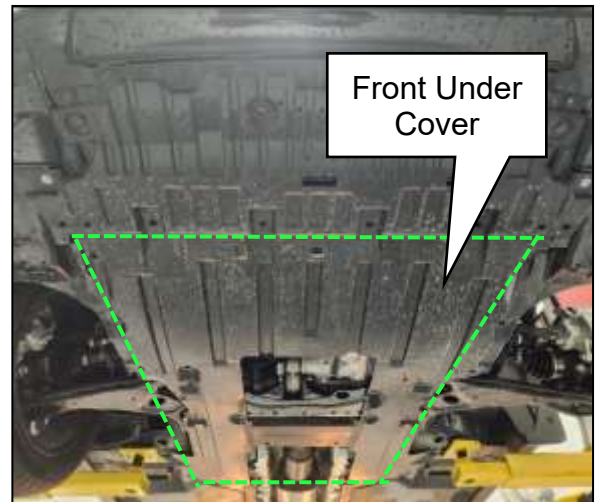
Figure 1

2. Remove the Front Under Cover.

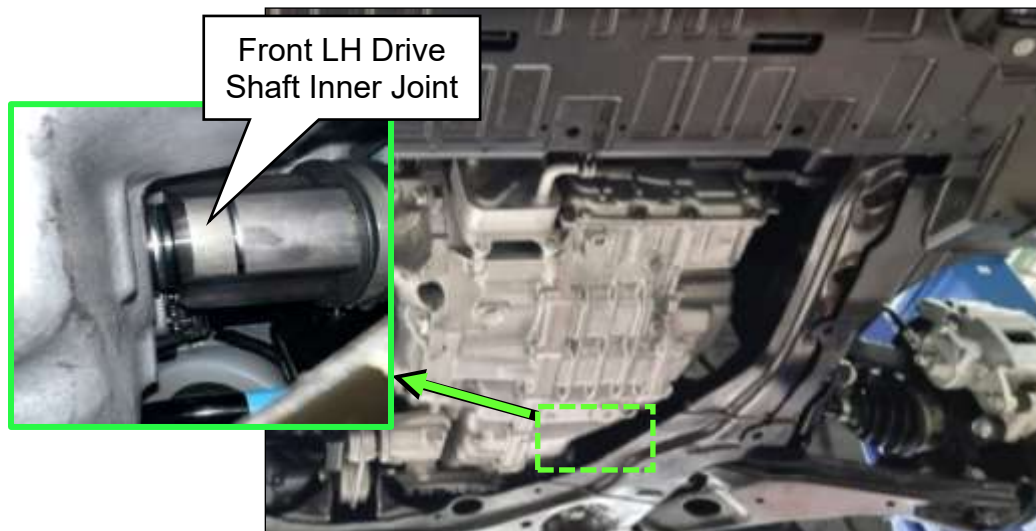
Figure 2

3. Locate the Front LH (driver side) Drive Shaft Inner Joint.

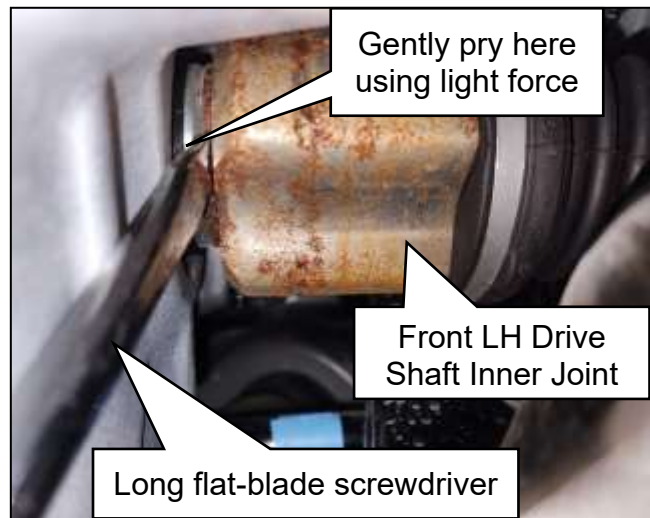
Figure 3

4. Verify the Front LH Drive Shaft is fully seated in the transaxle.

**HINT:** When the Front LH Drive Shaft is NOT fully seated in the transaxle, the Drive Shaft will move outward easily with little to no pry force.

- a. Place a long flat-blade screwdriver between the Front LH Drive Shaft and the transaxle case, as shown in Figure 3.
- b. Using light force, gently pry the Front LH Drive Shaft outward (away from the transaxle case) while watching the Front LH Drive Shaft Inner Joint for movement.

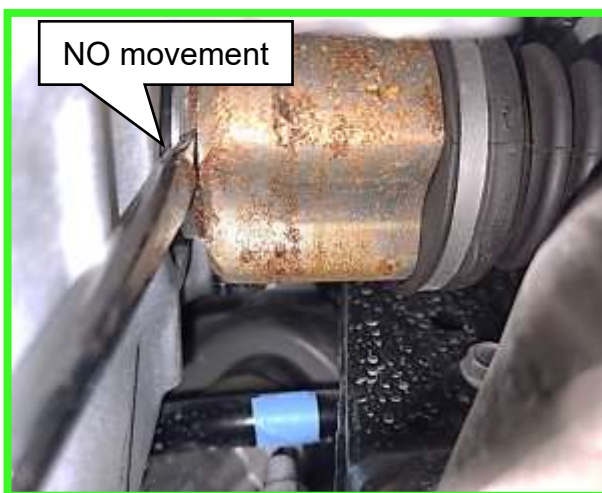
Figure 4

5. Did the Front LH Drive Shaft Inner Joint move outward when gently prying away from the transaxle case?

**NO:** Drive Shaft did NOT move, Good Result: No further action is necessary. Reinstall the Front Under Cover and proceed to **CLAIMS INFORMATION** on the last page.

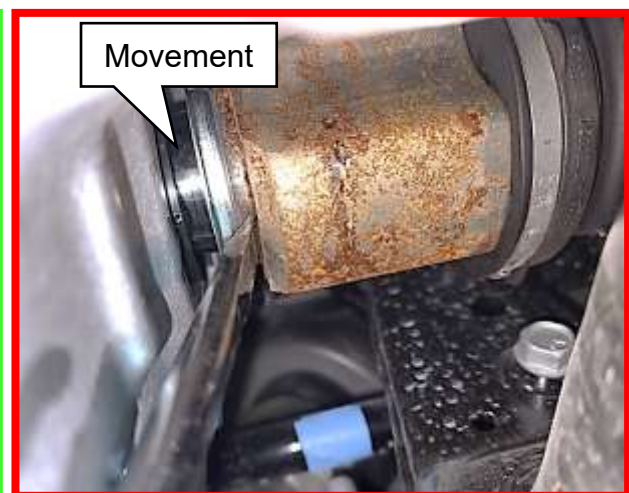
Figure 5

**YES:** Drive Shaft moved, No Good Result: Continue to step 6.

6. Submit a video with the movement and the applicable VIN to Warranty Validation Team for pre-approval, then continue to step 7 on page 5 to replace the Front LH Drive Shaft and the CVT.
