# SAFETY RELATED RECALL

Global Recall Action  
Number: D145

| <b>Subject:</b><br><br><b>Rear View Camera</b> | Publication No.: D145 |
| | Model: Discovery (LR) |

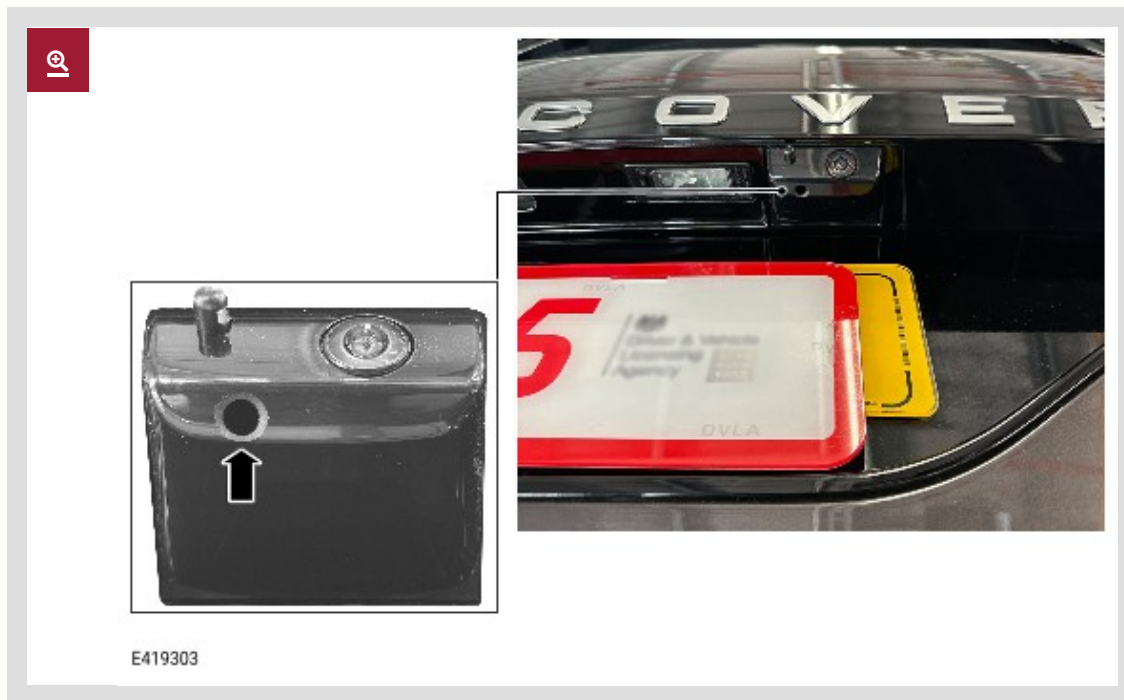
1. The photograph shows the expected outcome and required quality of finish for the drilled hole, after completing the Service Instruction, below.
