## Technical Service Bulletin

**GROUP****RECALL****NUMBER****26-01-066G****DATE****JULY 2026****MODEL(S)****G80 (RG3)****SUBJECT:**

IGNITION COIL GROUND BOLT RETIGHTENING  
(RECALL 034G)

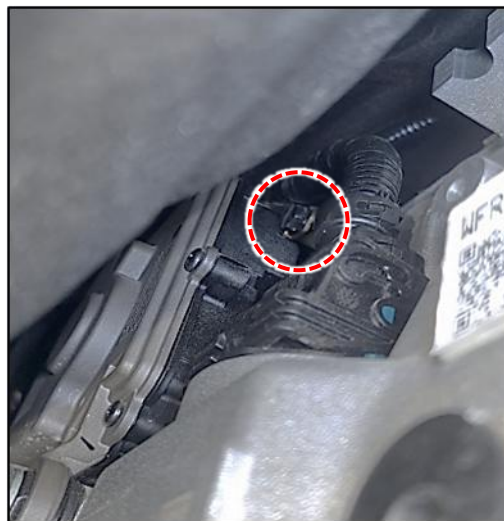
**Description:** Certain 2027MY G80 (RG3) vehicles may have an ignition coil ground bolt (GC101) that was not sufficiently tightened during vehicle assembly. A loose ground bolt could cause an engine misfire with illumination of multiple warning light(s), or in limited instances, an engine stall. This bulletin provides instructions to retighten the GC101 ground bolt.

Ground Bolt Location on top LH side of the Transmission
