# SAFETY RECALL

## Second-Row Seat Belt Buckle Anchor

Reference: 67D / NHTSA 26V-495

2019-2026 (DT) Ram 1500 Pickup

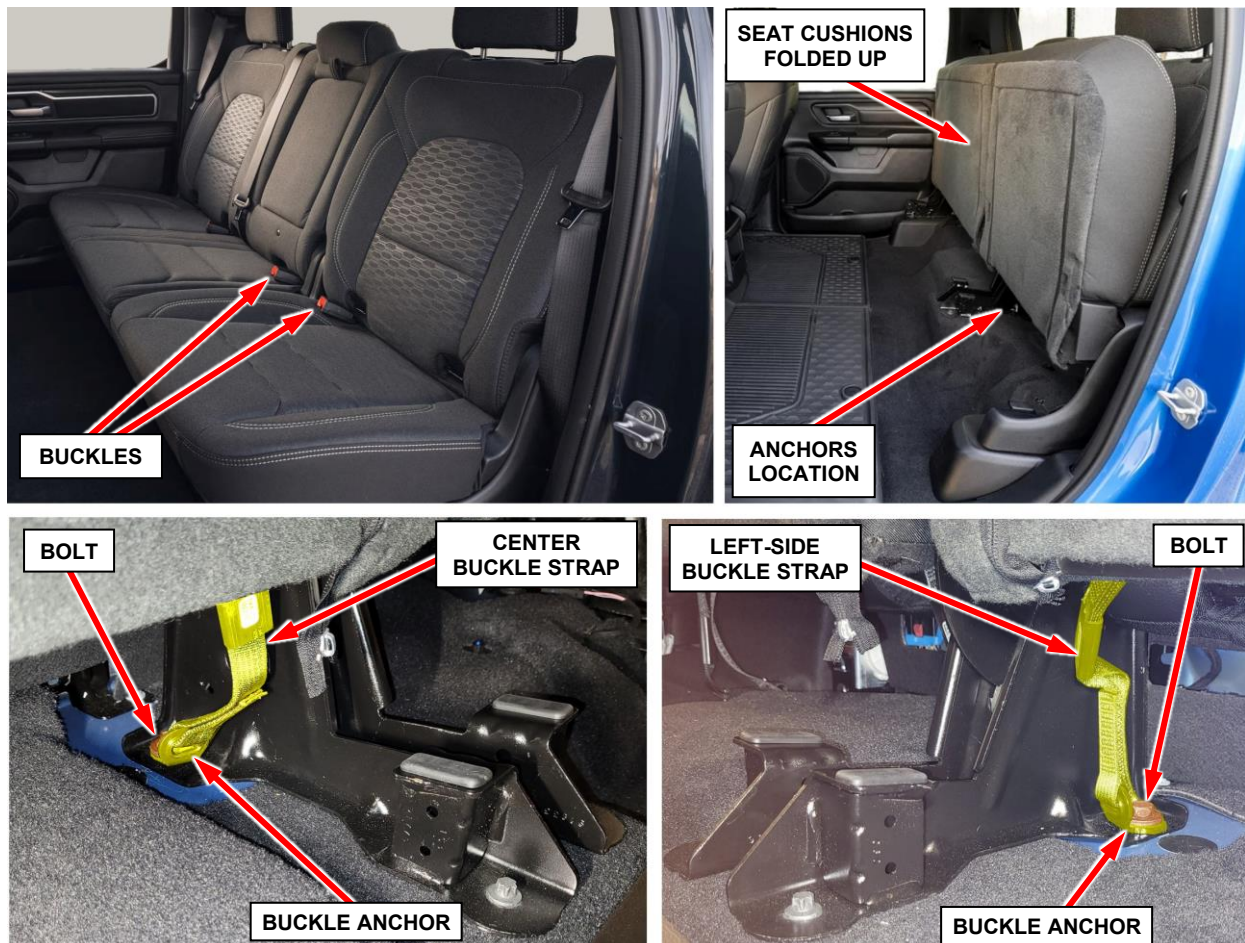
**Figure 1 – Second Row: Center and Left-Side Seat Belt Buckle Anchors**

The second-row center and/or second-row driver side seat belt buckle anchor on about 1,271,294 of the above vehicles may not have been properly attached to the body structure during vehicle assembly, which may result in reduced occupant restraint capabilities. Reduced load management by the seat belt buckle may result in injury to vehicle occupants in certain types of driving conditions or crashes.

1. Fold the second-row seat cushions up to access the center and left-side seat belt buckle anchor bolts (Figure 1).
2. Visually inspect to confirm both seatbelt buckle anchors are secured to the vehicle with the bolt. If not, replace the bolt and tighten to 55 N·m (41 Ft. Lbs.) (Figure 1).
3. Grasp the seatbelt buckle anchors and try to move or swivel them around the bolt. If movement is possible, replace the bolt and tighten to 55 N·m (41 Ft. Lbs.) (Figure 1).
4. If the seatbelt buckle anchor passed the first two inspection steps or was repaired during one of the prior steps, the vehicle may be returned to the customer or inventory.
