**Non-Compliance  
Safety Recall  
Campaign****2025-2026MY  
EV9 (MV1a)**

**SC379****October 2026**

### ODS BLADDER HOSE INSPECTION AND SEAT CUSHION ASSEMBLY REPLACEMENT (SC379)

This bulletin provides information to inspect, and if necessary, replace the front passenger seat cushion assembly on certain 2025-2026MY EV9 (MV1a) vehicles produced from May 17, 2024, through May 13, 2026 to address a potential issue involving the Occupant Detection System (ODS). The Occupant Detection System (ODS) mat bladder tube, which is located under the front passenger seat cushion, may become pinched when the seat is adjusted to the highest position due to improper routing of the tube. Repeated adjustment of the front passenger seat height/tilt may damage the bladder tube. If this condition occurs, the ODS may not suppress the deployment of the passenger front airbag for a child in a child restraint system (CRS) in the event of a crash. As a result, the subject vehicles do not comply with the suppression requirement of FMVSS 208, "Occupant Crash Protection," increasing the risk of injury to a child in a CRS in the event of a crash due to deployment of the front passenger airbag. Follow the proce

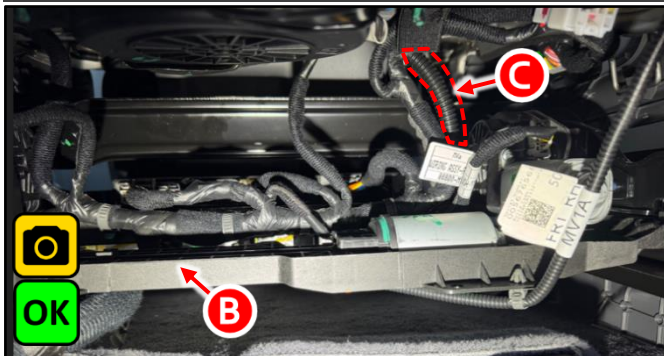
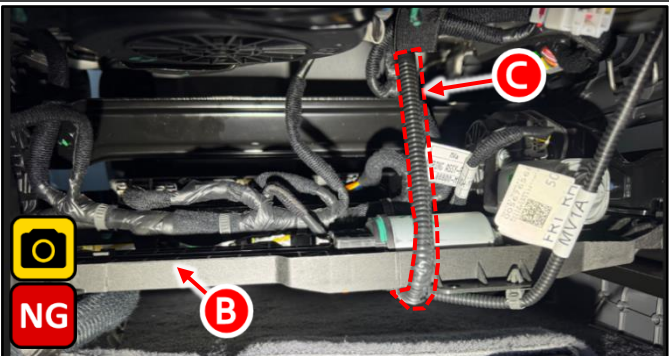
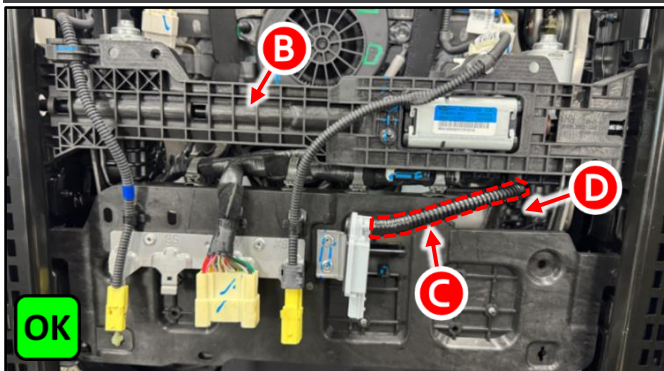
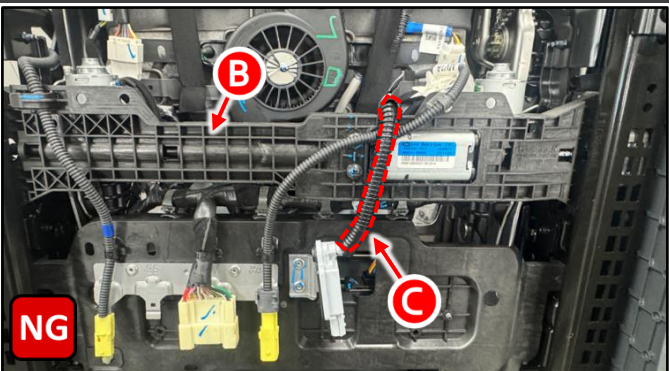
- Locate the ODS bladder hose and inspect its routing. The hose (C) should be **routed forward of the slide motor bracket (B) and through the opening (D)** on the right side. Ensure the **hose has no kinks and is not under tension due to contact with surrounding components**. See **OK** and **NG** (not good) example photos. Bottom views are shown for demonstration purposes only, **DO NOT REMOVE THE SEAT** from the vehicle.

If the inspection result is **OK**, one (1) inspection photo is required to be submitted using the KDS Warranty Claim Attachment tab. The photo must be taken from the rear and clearly show the bladder hose routing as in the example. **No further action is needed.**

If the inspection result is **NG**, two (2) photos are required to be submitted using the KDS Warranty Claim Attachment tab: a photo during this inspection step showing improper bladder hose routing, and a photo of the completed seat cushion assembly replacement after Repair Procedure, Step 8. The photos must be taken from the rear and clearly show the bladder hose routing as in the examples. **Proceed to the Repair Procedure.**
