# Compliance Recall

## Code: 57KL

#### Body Control Module (BCM) Software

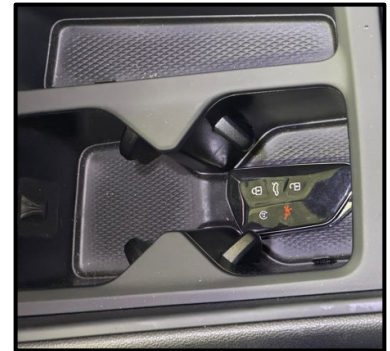
- Place the key over the reader coil in the cup holder.
- Use operating mode, DIAGNOSIS.
- Select "SVM – Code Input".
- Enter SVM code **5518** and follow the on-screen prompts.
- If the error "vehicle immobilizer is not activated" is received during the software update, perform the following steps:
  - Rotate the key 180° in the cup holder over the reader coil.
  - Cycle the ignition off and back on.
  - Reattempt the software update.
