## IMPORTANT SAFETY RECALL

NHTSA Recall No. 26V-006

# SAFETY NOTICE

SUBJECT: Upper Control Valve – Enable Cavity Plugs

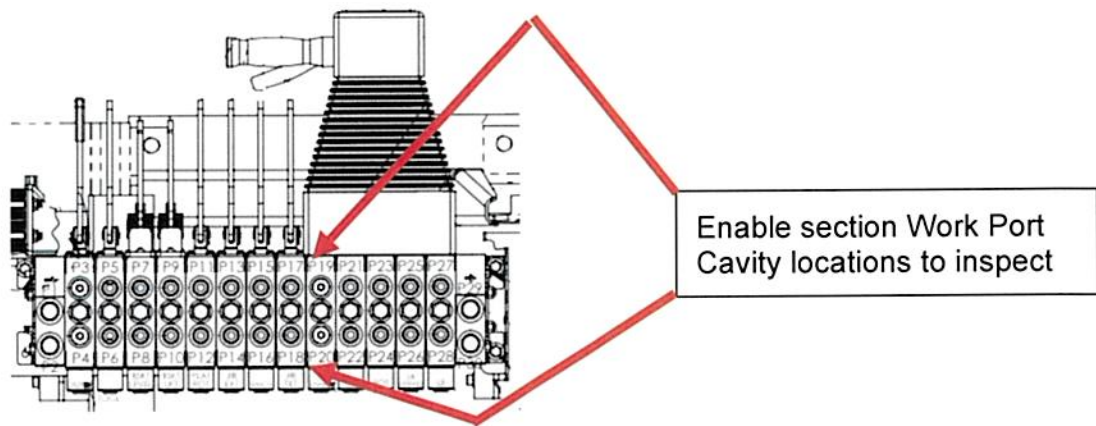
Valve assemblies 462052, 481326, 485616, and 486437 may have been assembled with No Relief (NR) plug in the enable section of the upper control valve for units built from January 1, 2025 to September 9, 2025. The plug in the enable section work port cavity should be a standard SAE O-ring plug to allow oil flow into the return passage when the enable is not engaged. The NR plugs will cause flow across the lower relief valve if upper controls are selected and the enable functions are not operated. It will also hold the engine speed on high throttle if demand throttle is installed. **Continued use will increase the oil temperature and may cause burns.**

- Figure 1 - Typical location to inspect of upper control valve enable section

08MB Hollow Hex plug 411585 Color is silver

Figure 2 – Correct Plug in the enable section cavity locations as shown above.

No Relief Plug 446951 (NR Plug) – Exterior paint is black and color under paint is silver

Figure 3 - NR Plug graphics which should not be in the enable section work port cavities.

2. Position the platform where you can look at the upper control valve. Shut off the engine and relieve the pressure by depressing the STOP control at the platform. Position a pan or rags to collect oil spillage and remove the upper and lower work port cavity plugs from the enable section using a 5/16 Allen-Wrench as pointed out in figure 1. If the plug is an NR plug as shown in figure 3 replace with standard plugs as shown in figure 2.

Perform one or more of the inspections above. Refer to the pictures below for clarification. If the plug are black in color or verified by visual examination the incorrect plug is installed and must be removed and replaced with a standard SAE 10 Hollow Hex Plug, 411585 included in Z1765. Fill in the completion record included with the owner letter and return.
