L74X-
R.01.26

To: After Sales Official Network
Object: Rear View Camera Black Screen
Date: 13/03/2026
Pages: 13

Campaign name:
Rear View Camera Black Screen

Model:
Revuelto

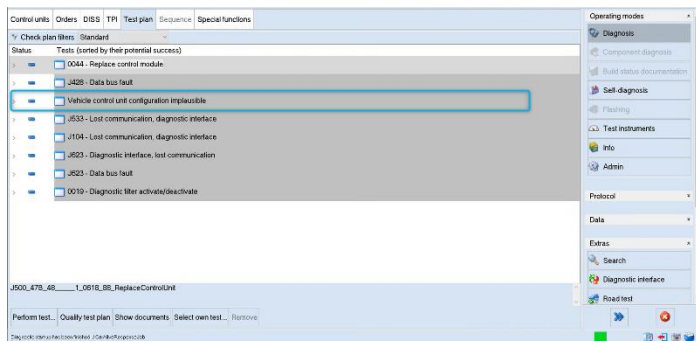
23. Check the DTCs from the ECU 0019: If the DTC “C12A5F0: Vehicle electrical system configuration implausible” is present and is in “active” status, please perform the GFF “**Vehicle configuration implausible**” from the Test Plan, as shown below:

Entries in event memory	
Number:	C12A5F0: Vehicle electrical system configuration implausible
Error type 2:	active/static
Symptom:	8519691
Status:	00001001

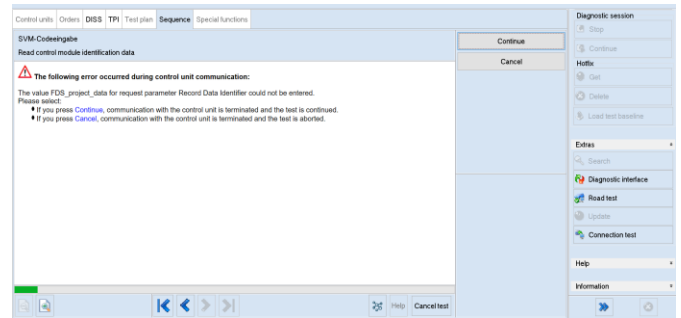
30. If the following error screen is displayed, the error does not indicate an issue, please press “Continue” and continue with the campaign.

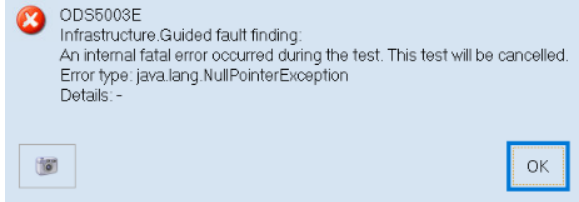
Errors

- **8118** → please perform a sleep cycle. Be sure the control unit 5F has been updated to correct software (see previous steps). Check the software level via 5f – control unit identification and compare it to the reference table. Repeat SVM code and contact Technical Support if not resolved.
- **8037** → Please check your O.D.I.S Service version and hotfix as indicated in “Preliminary operation” section.
- **9024** → Please retry the SVM code after 30 minutes.
- **9999** → For the owners of the new D3 Edge Box, please refer to the informative bulletin BI.08.24 to check the correct O.D.I.S Service connection setup.
- **ODS5003E** → If the following screen appears please close and repeat the SVM-Code.

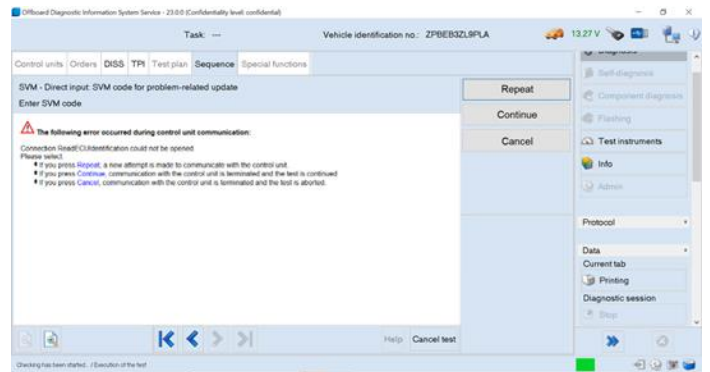
A. If the following error screen is displayed, abort the guided function by clicking on “Cancel Test” and contact Technical Support.

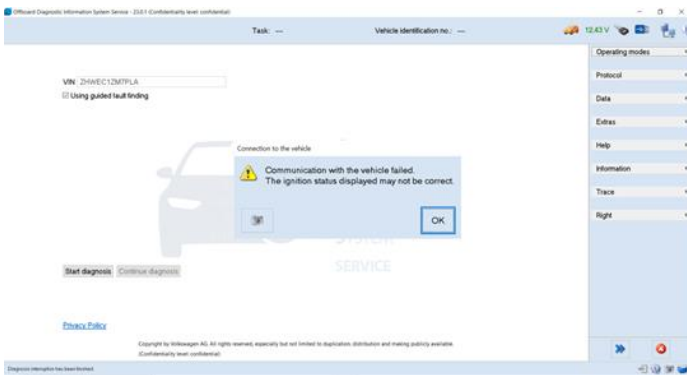
B. If an error is displayed that regards the hardware interface, and the "connection to vehicle" and "key state" icons appear as shown in the figure below:

- Click "Cancel";
- Repeat installation of the interface VAS6154/6154A/6154B for the instructions in procedure (*) "Checking the VAS 6154", selecting the right-hand "Extras" menu in O.D.I.S. Service and clicking on the "Diagnostic interface" button.

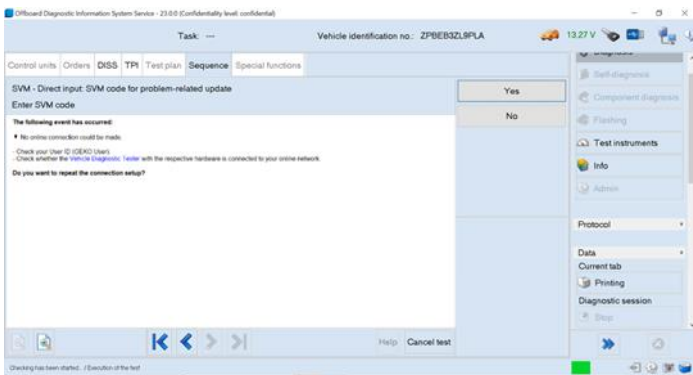
C. If the following connection error is displayed like in the following example screenshots:

- It is not possible to connect to the central server; check that your laptop is correctly connected to the Internet and retry by clicking on "Yes" or "Done/continue", as appropriate.

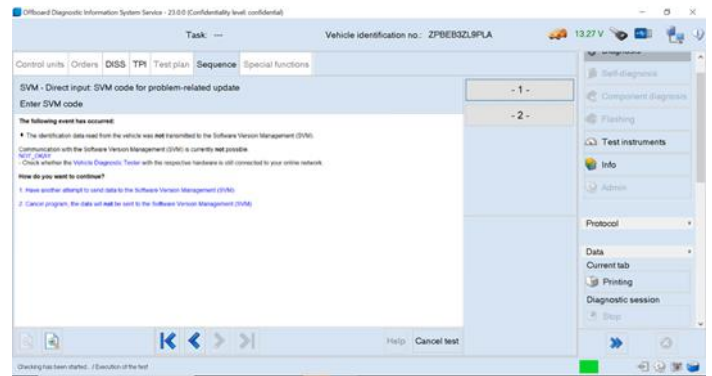
D. If the connection is dropped during the target/actual comparison during the SVM procedure:

- It is not possible to connect to the central server; check that your laptop is correctly connected to the Internet and retry by clicking on "1".
