Safety Recall: 2024 HR-V Driver's Seat Lift Link Bolt Loose

Year	Model	Trim Level	VIN Range
2024	HR-V	EX-L	Check iN VIN status for eligibility.

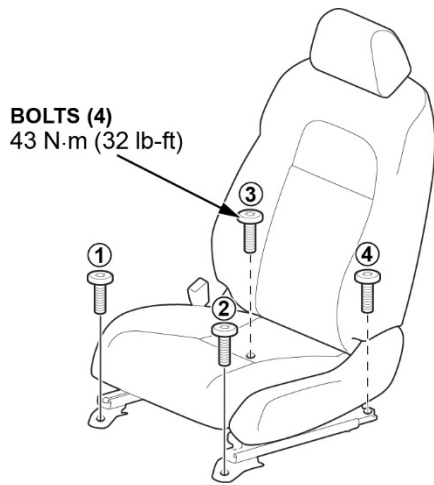
Four (4) units may have received a driver's seat cushion frame during production in which some bolts were improperly torqued and, over time, could loosen and fall off. If a bolt falls off, the driver's seat may become unsecured and rock or wobble during use, increasing the risk or severity of an injury in the event of a crash.

13. Install the driver's seat into the vehicle. Hand tighten the bolts, then torque the bolts, in sequence, using a 50 IP TORX Plus socket driver.
