## RECALL ACTION

| Reference number: | RA-41-2086 | Issue Number: 1 | Issued: 20 March, 2026 |
| Subject: | DBX Rear Lower Arm Bolt | | |
| Model(s): | DBX, DBX Straight Six, DBX707 and DBX S | | |

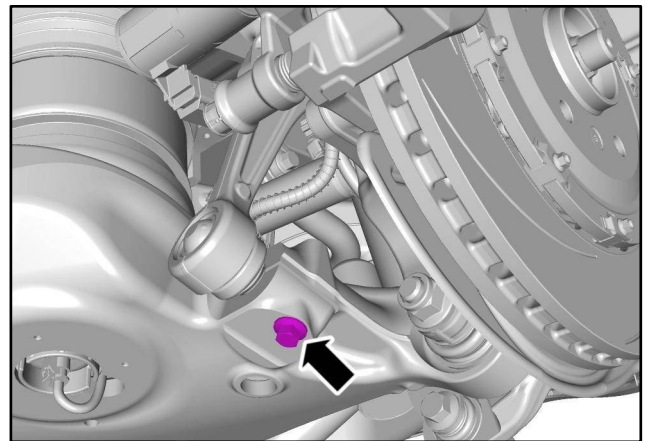
Figure 1

On affected vehicles, a reduced diameter shank bolt can cause the pin for the torque reaction link to move within the joint causing excessive wear and potential early failure.

1. Remove the bolt that attaches the left-side rear torque reaction link to the rear suspension bottom arm and discard the bolt (refer to Figure 1).

2. Install the new bolt and torque to 50.0Nm plus 60° angle.
3. Remove the bolt that attaches the right-side rear torque reaction link to the rear suspension bottom arm and discard the bolt (refer to Figure 2).
