May 29, 2026

Version 4

Safety Recall: 2018–22 Odyssey SRS Software Update**Supersedes Version 3 to revise the information at:**

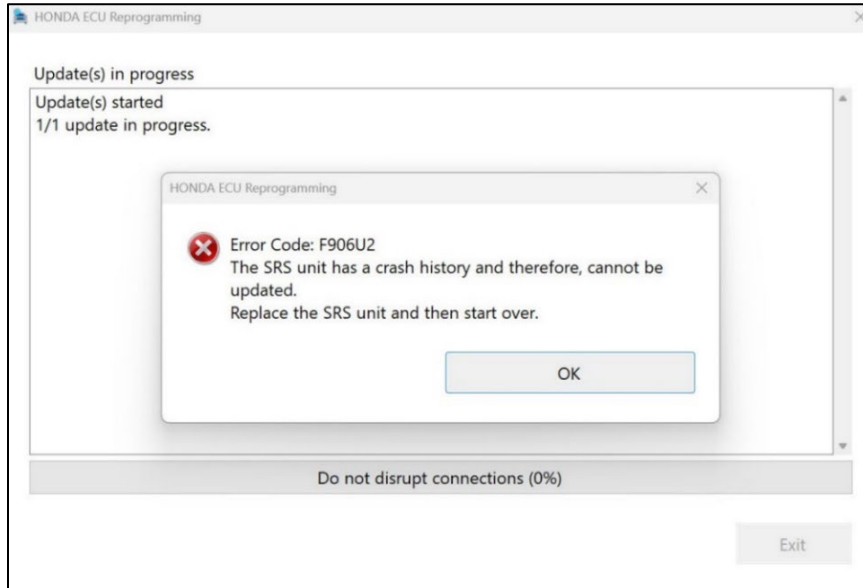
- If the SRS unit cannot be updated and displays the following error message, proceed to **REPAIR PROCEDURE B**.
- A clear photo documenting the HDS screen failure **will be required** for warranty processing.
