# TSB 611548 - Recall 26V357

## Recall 26V357 - 2026 Ram ProMaster Side Entry — Wheelchair Seat Belt Replacement

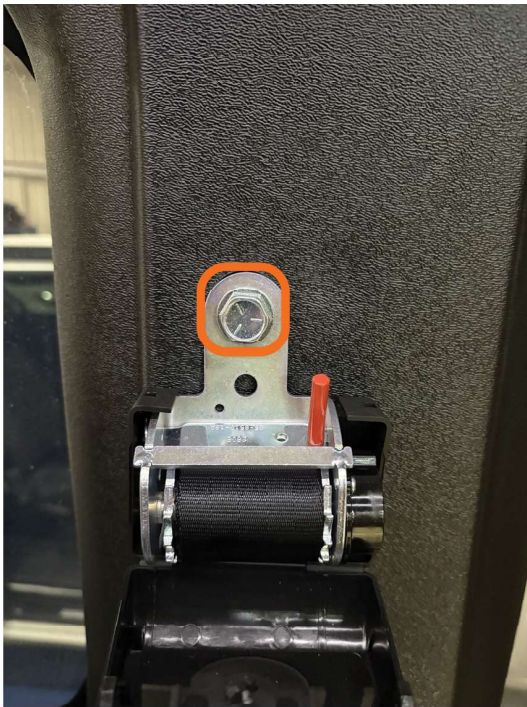
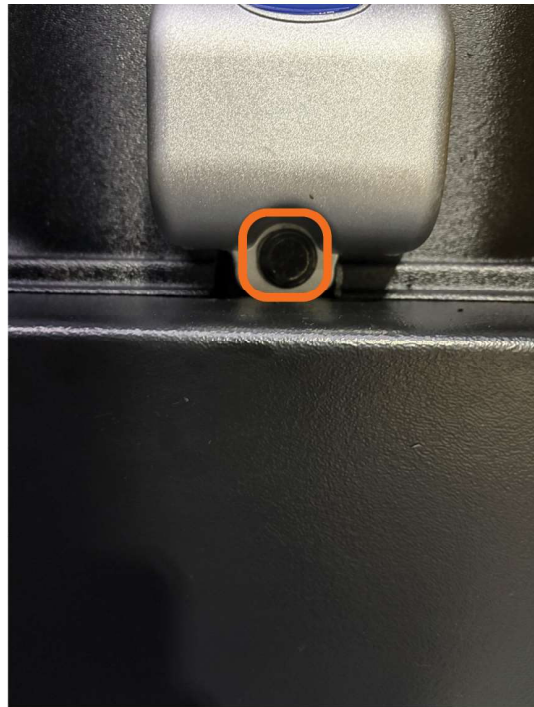
Affected vehicles were built with the Q'Straint One-Combo Belt (**TX11258-BA**) — a single-piece combo belt that is the wrong configuration for this application. It is missing the lap belt portion required to properly restrain a wheelchair-seated person. Improperly restrained occupants have an increased risk of injury in the event of a crash.

- a. Unbolt the top and bottom of the recalled TX11258-BA combo belt from its mounting points.
- b. Retain the bolts for reuse.
- c. Set the removed TX11258-BA aside for return/disposal per BraunAbility recall instructions.
