# 2025–2026 Chrysler Pacifica & Voyager Side Entry — Front Seat Harness Wall Connector Spring Inspection and Repair

Version B

**Concern:** Affected vehicles were manufactured with an incorrect spring inside the wall connector for the front seat harness, on both driver and passenger sides. This procedure provides the inspection criteria to confirm whether repair is required, and the replacement procedure if it is.

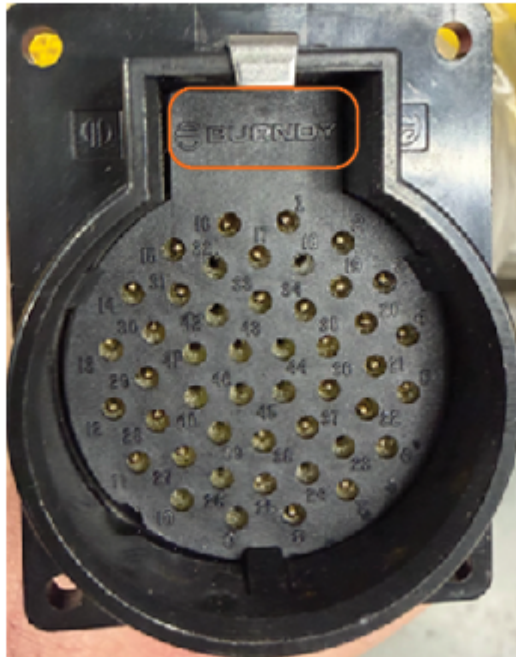
#### Exclusion Criterion A — Burndy-Marked Plate

- Look at the plate inside the wall connector.
- If the plate is stamped/marked "**Burndy**," the correct spring is already installed. **No repair required.**

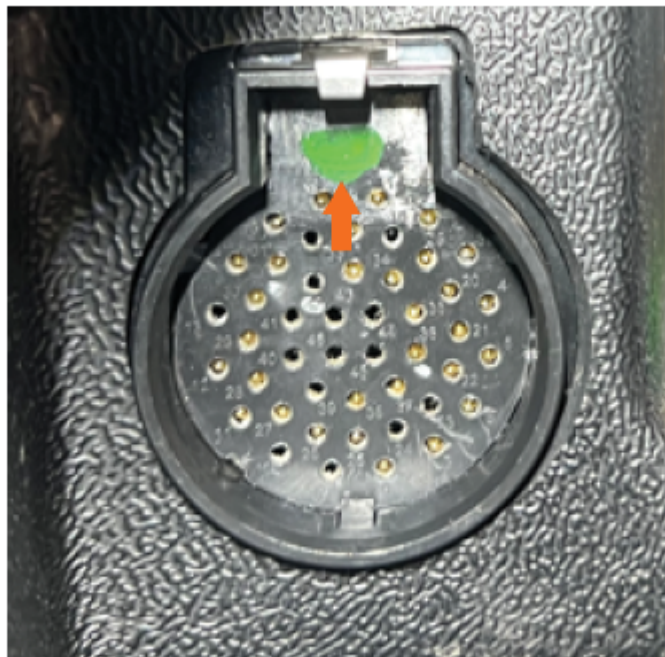
#### Exclusion Criterion B — Green Paint Mark

- Look for a **green paint mark on top of the connector AND inside on the plate.**
- If both green paint marks are present, the connector has already been inspected/repaired. **No repair required.**
