**HYUNDAI**  
**Technical Service Bulletin**

NUMBER  
**26-01-058H**

MODEL(S)  
**IONIQ 5 (NE EV)**

**SUBJECT:** BATTERY SYSTEM ASSEMBLY (BSA) REPLACEMENT  
(RECALL 305)

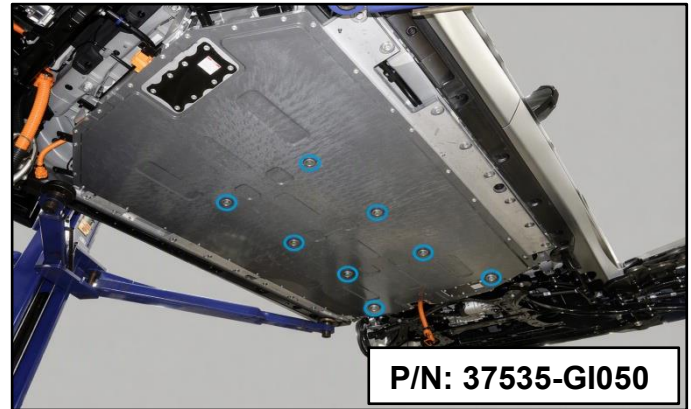
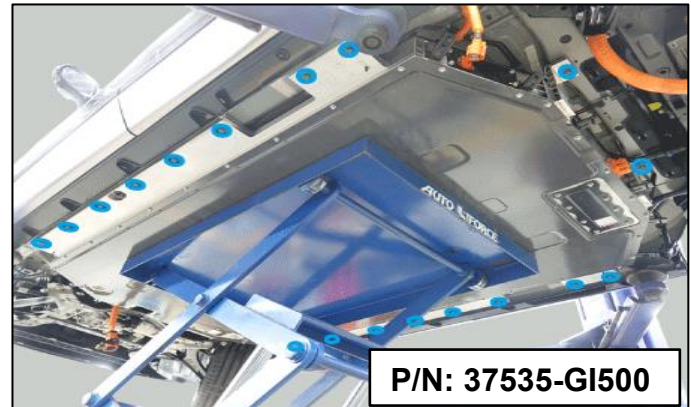
Ensure that all **26** one-time bolts are replaced per the shop manual procedures.

2. Replace the BSA by referring to the shop manual:
  - **Battery Control System > High Voltage Battery System > Battery System Assembly (BSA) > Removal and Installation**

Applying the recommended torque to all fasteners is essential to reduce potential issues from occurring after the service procedure.
