# TSB 612238 - Recall 26V434

## Fuel Fill Assembly Field Remedy, 2026 Chevrolet Traverse Side Entry

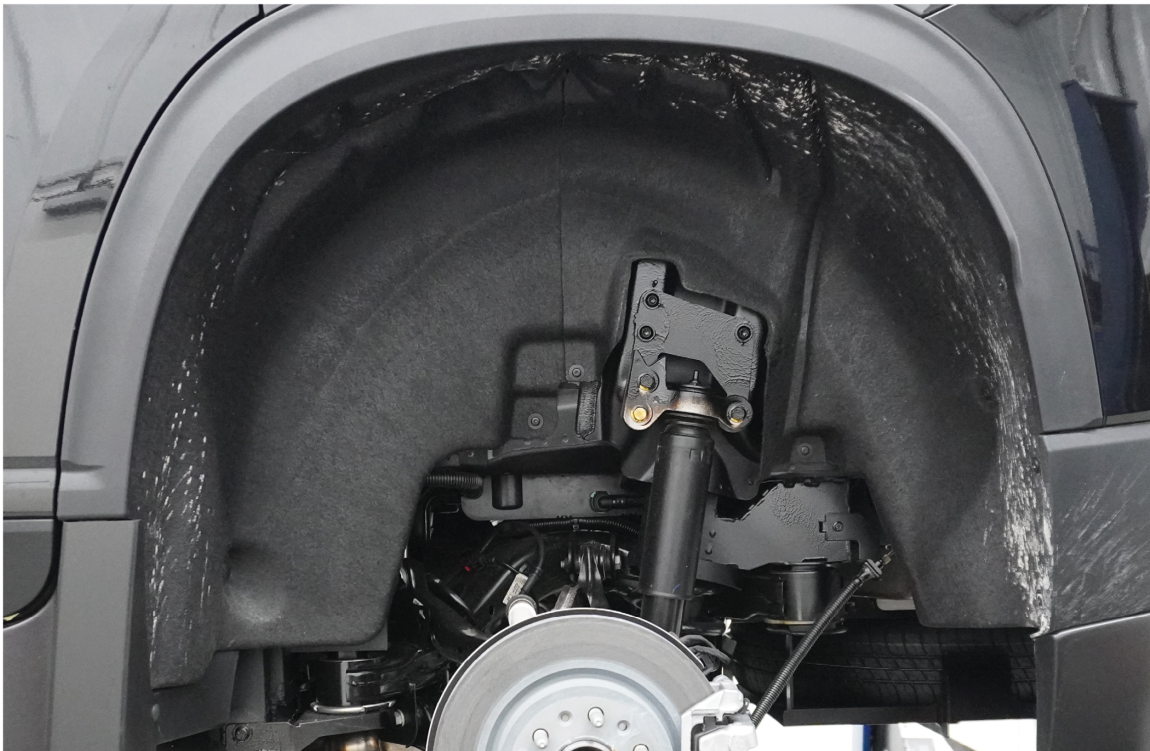
The wheel-well liner is a two-piece assembly joined by a center fastener.

1. Remove all wheel-well liner fasteners **except the center fastener** that joins the two liner halves.
2. With the outer fasteners removed, the liner assembly can be removed as a single unit.

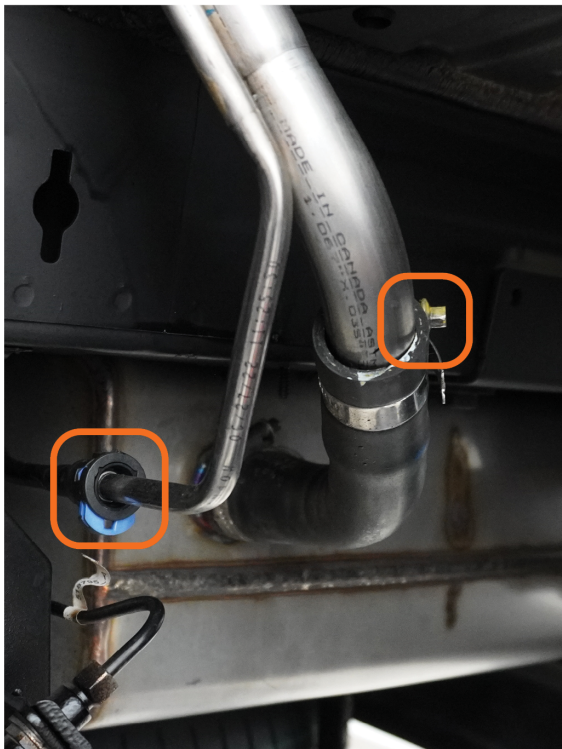
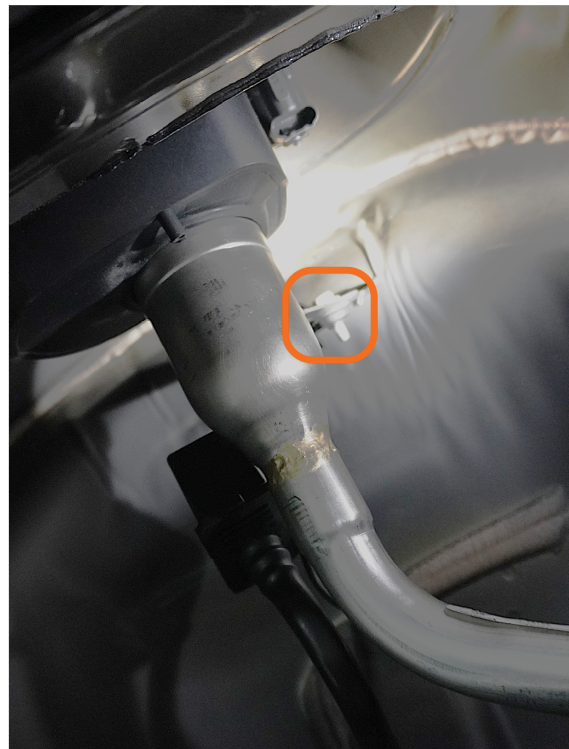
## Step 6 — Remove the Upper Mounting Bolt at the Fuel Fill Bracket

1. Remove the OEM fastener at the top of the wheel well that secures the fuel fill mounting bracket.
2. Retain the OEM fastener for reuse.

- **Upper mounting bolt at fuel fill bracket:** Torque to **35 in-lb**.
- **Lower fill tube clamp:** Torque to **35 in-lb**.
- **Recirculation tube:** Verify the built-in retaining clip is fully engaged.
- **Fuel filter:** Secure it to the fill tube with a **new** cable tie 513495-10KS.
- **Wheel-well liner:** Reinstall with all retained fasteners. Replace any damaged fasteners.
- **Driver-side rear wheel:** Reinstall the tire.
