# Gen 1 trailer tongue reinforcement

Cracking has been reported at the bend in the trailer tongue weldment D63856-998-SK. A reinforcement plate is now available to retrofit trailers in the field.

| BULLETIN NO. | DISTRIBUTION DATE | C LASSIFICATION | TIMELINE | WORK INSTRUCTION |
|---|---|---|---|---|
| 26-01 | August 26, 2026 | Service | Immediate | ASWI-59 |

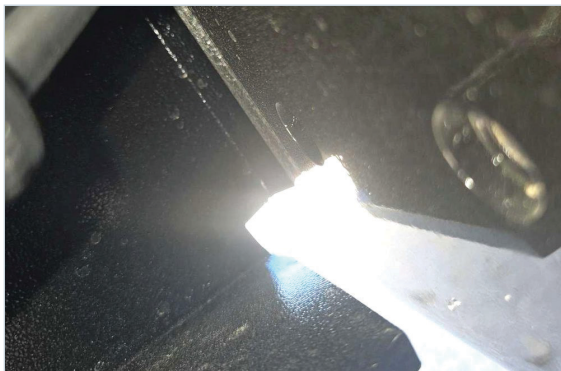
Cornell has received reports of cracking and failure at the trailer tongue joint on Gen 1 trailers. The cracks start along the bend in bent-plate tongue D63856, where the tongue meets the frame.

**Fig. 1 — Reported failure.** A complete break along the bend of the tongue. Daylight through the joint confirms the crack has gone through.

Cornell has released reinforcement plate A79932, which bolts onto the tongue in the field — two plates per trailer, one each side. Where damage is already present, Cornell will supply a replacement tongue with the reinforcement factory-installed.

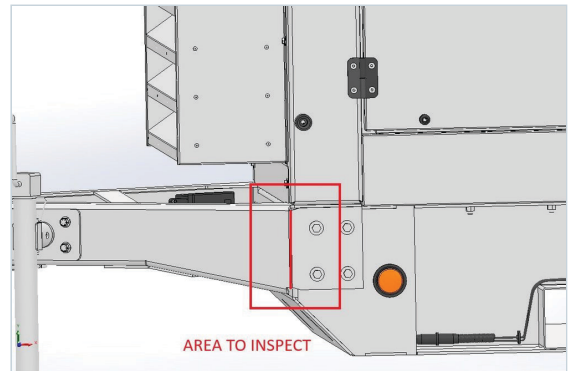
**Fig. 2 — Area to inspect.** Check the full length of the bend where the tongue meets the frame, on both sides of the trailer.

- Park the trailer.** Transport affected trailers on a trailer or rollback until the reinforcement retrofit has been installed.
- Retrofit every trailer.** Install the reinforcement plates on both sides and inspect the tongue at the time of installation.
- Report what you find.** If the tongue is already cracked, call the factory before the trailer goes back into service.
