## IMPORTANT SAFETY RECALL 26510

### Interim Notice

NHTSA RECALL NO. 26V459

International Motors, LLC\* has decided that a defect which relates to motor vehicle safety exists in certain 2021 and 2023 thru 2027 International® MV™ Series trucks built 09/21/2020 thru 06/16/2026 and 2026 thru 2027 International® HV™ Series trucks built 07/02/2025 thru 06/16/2026, with the following unique configurations (feature codes):

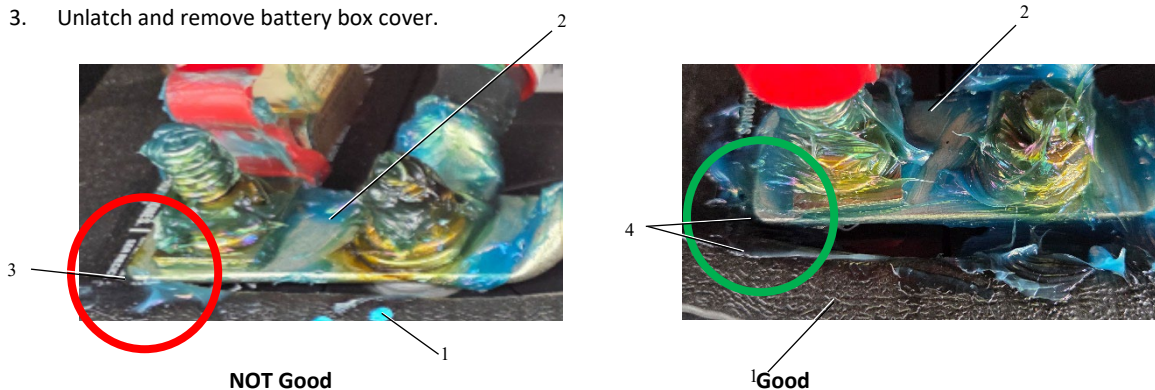
**Figure 1. Overview of Interconnect Cable**

Manufacturing variation can allow for contact between the battery interconnect cable with auxiliary stud and hold-down bracket.

When contact between these components occurs, a short circuit can develop which may generate excessive heat, which can result in a fire, increasing the risk of property damage or personal injury.

1. Positive battery Interconnect Cable
  2. Battery hold-down (with or without windlace)
  3. Interconnect terminal touching battery hold down – No Clearance
  4. Interconnect terminal not touching battery hold down – Proper Clearance
4. Refer to Figure 1 to verify clearance between battery interconnect terminals and battery hold-down.
    - a. Your vehicle may or may not have rubber windlace on the battery hold-down as indicated in the picture. At this time there is no need to remove or install the rubber windlace.
    - b. It may be necessary to remove a small amount of grease to verify the clearance. It is not necessary to remove all the grease or replace the grease.

5. If there is contact between the battery interconnect terminal and the battery hold-down, it is recommended to do the following.
  - a. Loosen nuts on positive interconnects.
  - b. Loosen nuts on battery hold-down J-bolt nuts. (see Figure 2, Item 2)
  - c. Slide batteries apart. This will straighten the battery interconnect to provide the required clearance.
  - d. Verify clearance (no contact) between terminal and battery hold-down.
  - e. Hold interconnect cable in place and tighten battery hold-down nuts to 44-54 lb-in (5-6.2) N·m and positive battery nut to 12-15 lb-ft (16-20 N·m).
6. Install battery box cover.
7. Remove wheel chocks.

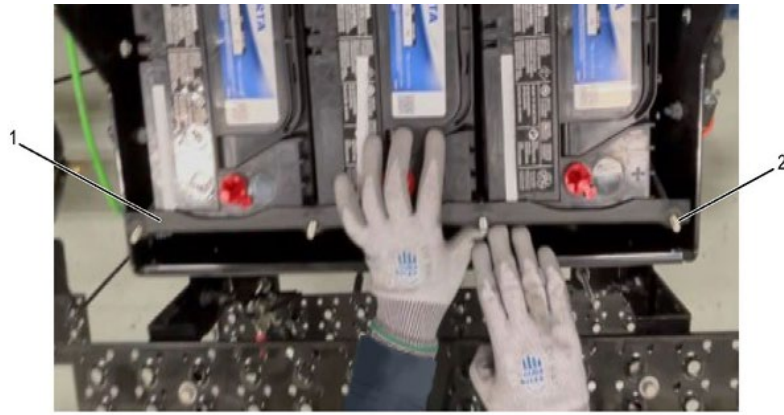
**Figure 2. Battery Positioning (Interconnect not pictured)**

1. Battery hold-down
2. J-Bolt (hold-down nuts)
