Applies To: 2000-01 S2000 - ALL

November 26, 2002

Convertible Top Does Not Open Properly**SYMPTOM**

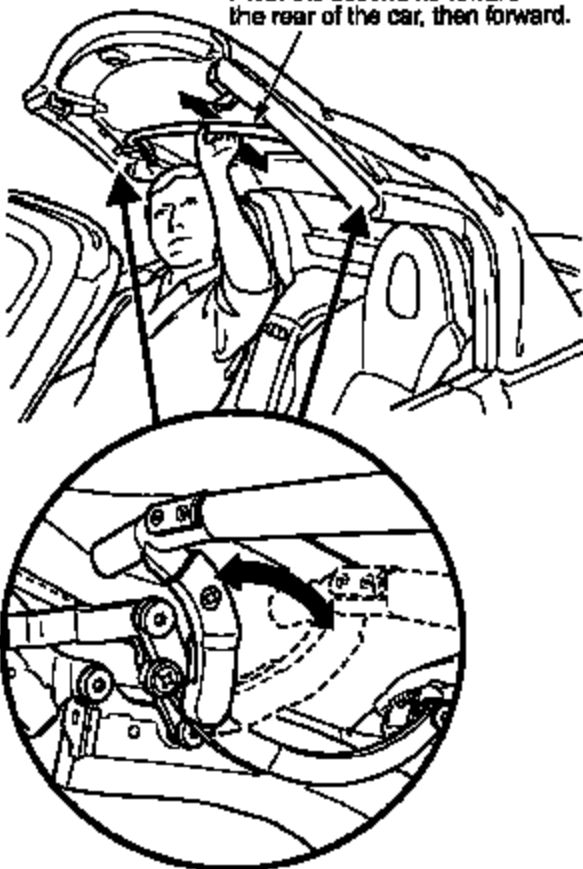
Pivot the second rib toward the rear of the car, then forward.

1. Unlatch the convertible top, and open the top approximately 12 inches.
2. Grasp the second rib of the convertible top and pivot the second rib toward the rear of the car, then forward.
 - If the second rib of the top does not pivot easily, go to step 3.
 - If the second rib of the top pivots easily, go to step 4.
