Tech-Net Notes

NO: 43-38
DATE: 2-27-2003
MODEL/YEAR: MY 2001-2002 S60 / V70 / V70 XC
SUBJECT: AW 55-50 Neutral Control Function, Valve Body Diagnosis, TCM DTC 012A and 012B
CHASSIS: See chart below

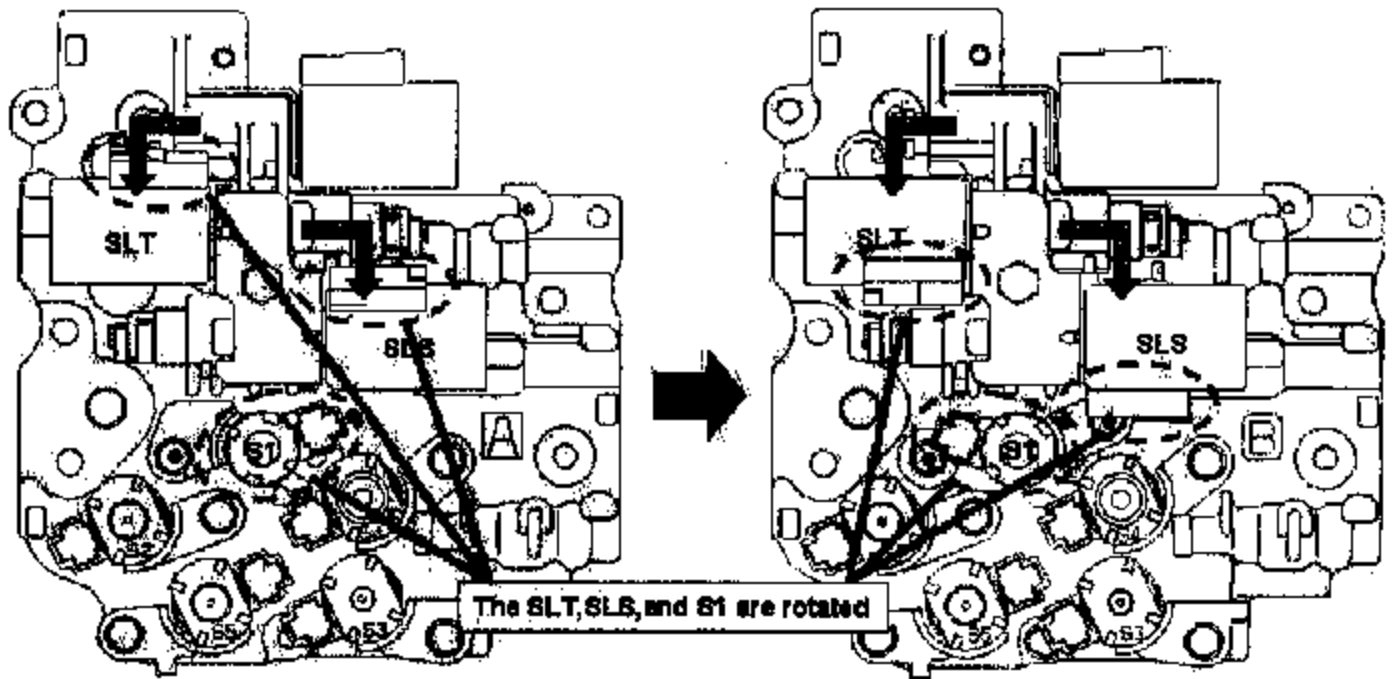
To prevent further contamination, the SLT and SLS solenoid have been rotated 180° on all new valve bodies. The S1 solenoid has also been rotated, to accommodate the change.

Because of these changes, the transmission wiring harness must be replaced with the valve body in order for the electrical connectors to reach the solenoids. The new harness is included in the following kits:
