## **Technical Service Bulletin**

TSB # T2006-02

**Product**: Gateway AI

**Model** #: GTWY401-A1 Rev 1.0 and Rev 2.0

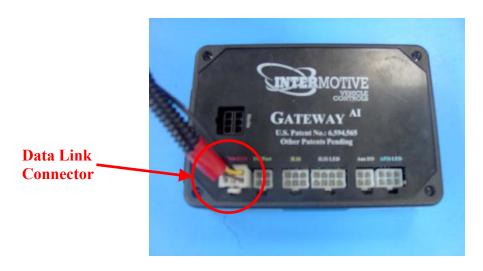
**Issue**: When the module transitions from its power down mode (ignition off) to its power up mode (ignition on) the module intermittently may not wake up. If this action occurs, the module's LED display panels will not prove-out and the backlights on the LED display panels will not illuminate.

**Action**: Disconnect and reconnect the data link connector on the module. The data link connector has red tape as its indicator. See picture below for a visual depiction of the data link connector.
