You will find enclosed a copy of Service Bulletin S07LN regarding the routing of the alternator power cable on your Blue Bird All American model bus(es).

# Alternator Cable Routing

MODELS AFFECTED: 2007 A3FE All American

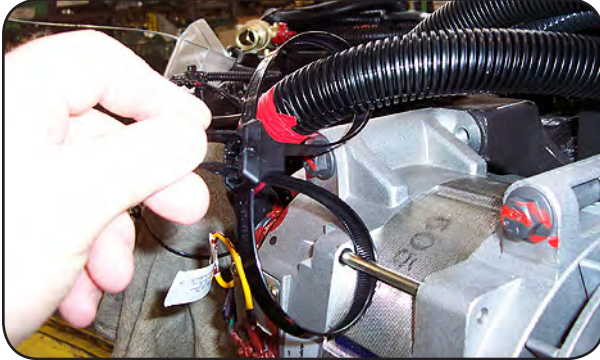
The alternator power cable is routed too close to the charge air cooler (CAC). This results in melting of the shrink wrap at the power cable connector exposing it to the elements.

The positive battery cable leading from the rear of the alternator to the Power Distribution Unit (PDU) may contact the charge air cooler tube.

*Before: Cable contacting CAC tube.*

4.1 With the terminal nut which secures the battery power cable to the back of the alternator loose, press the cable toward the right side of the alternator. Secure in place using the dual cable tie assembly looped around the cable and the bolt shaft of the alternator.

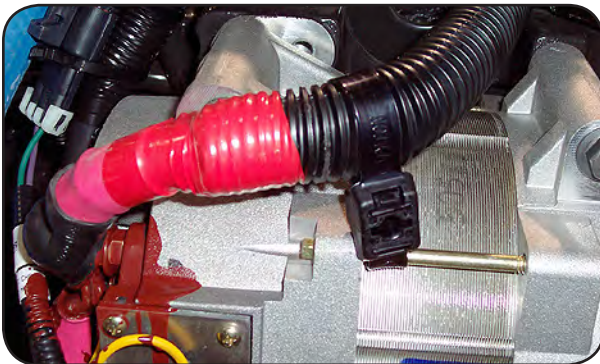
*After: Cable secured to prevent contact with CAC tube.*

4.2 Tighten the connector nut to 17-22 ft lb.
