You will find enclosed a copy of Service Bulletin S07MC regarding the tie rod ends on certain 2006-08 model year Blue Bird Vision (BBCV) buses.

Hendrickson Tie Rod Ends

MODELS AFFECTED: All Blue Bird Visions (BBCV)

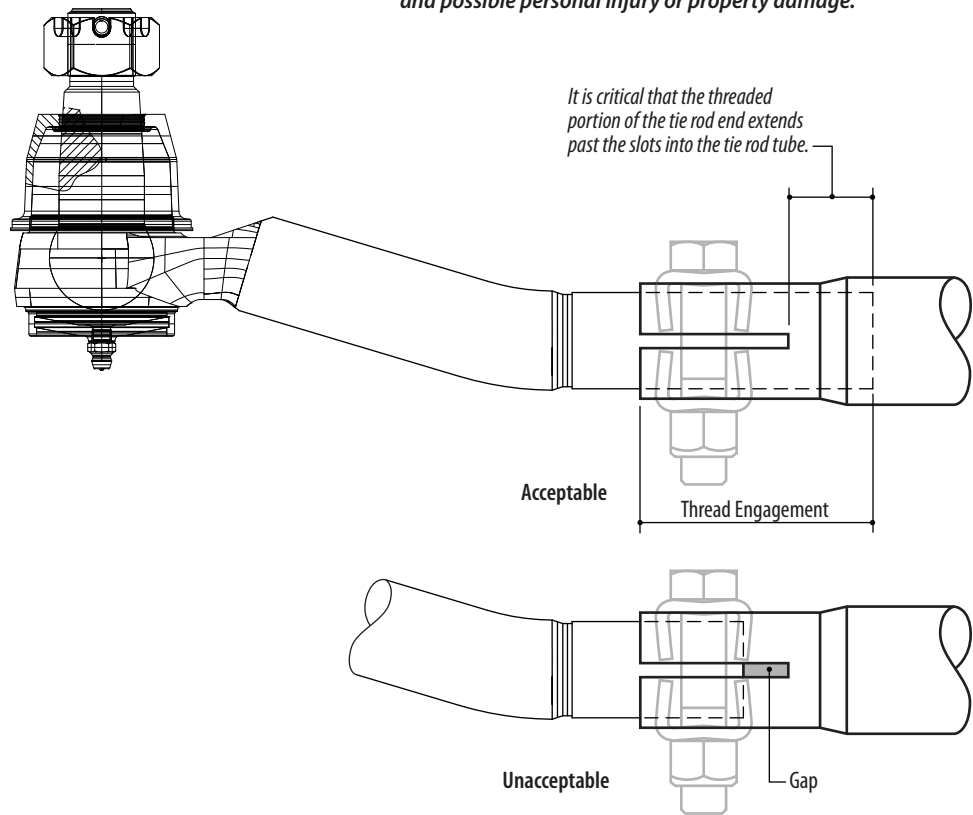
WARNING The threaded portion of the tie rod end must extend past the slots in the tie rod cross tube, failure to do so can cause component to fail causing loss of vehicle control and possible personal injury or property damage.

Inspect all Tie Rod Ends and/or Tie Rod End/Cross Tube assemblies, installed or purchased since July 2005. Inspect tie rod end thread engagement into cross tube. If threads do not extend past the end of the slot in the cross tube or if any gap exist between the tie rod end and the end of the cross tube slot, contact your Blue Bird Service Parts Representative for replacement parts.

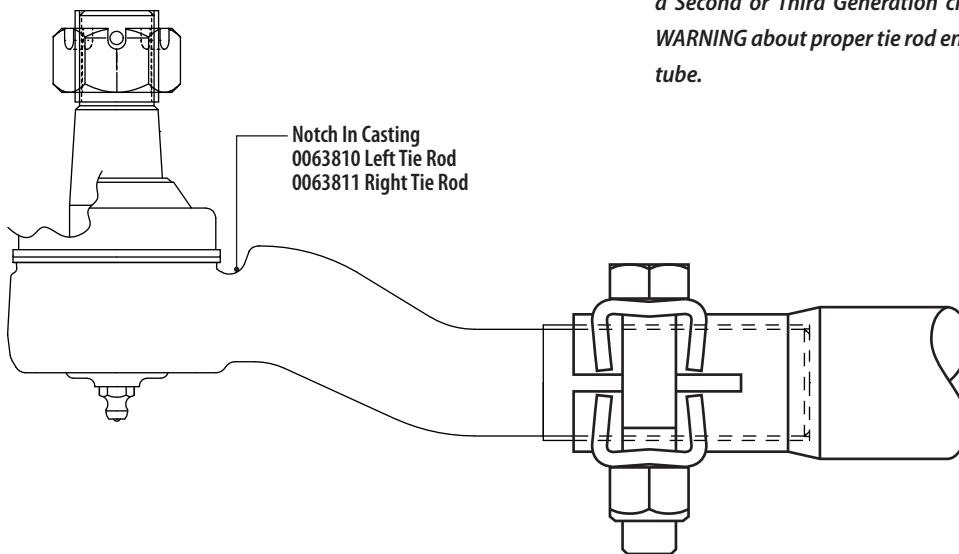
First Generation Tie Rod Ends

First generation tie rod ends were used on Blue Bird Visions from its launch date to mid July, 2005. This tie rod end can be identified by a “notch” in the casting very near the rubber bushing. The replacement part numbers for this style tie rod end are 0063810 (Left) and 0063811 (Right).

WARNING DO NOT use a First Generation tie rod end with a Second or Third Generation cross tube. Refer to Hendrickson **WARNING** about proper tie rod end thread engagement into cross tube.

Per Hendrickson Technical Bulletin SEU-0223 Tie Rod End Replacement Kits Revision B dated May 2007, the tie rod assembly and tie rod ends for these parts are obsolete and are no longer available. The entire tie rod assembly must be replaced. Per Hendrickson Technical Bulletin, Hendrickson Tie Rod End part number 66699-001 (Blue Bird 0094365) replaces Hendrickson Tie Rod End part number 59948-001, 59948-002 or 59948-006. Per Hendrickson Technical Bulletin, Hendrickson Tie Rod End part number 66699-003 (Blue Bird 0118467) replaces Hendrickson Tie Rod End part number 59948-004 or 59948-005. Note: The tie rod part number is located on the tie rod cross tube. Select the correct replacement for your vehicle.

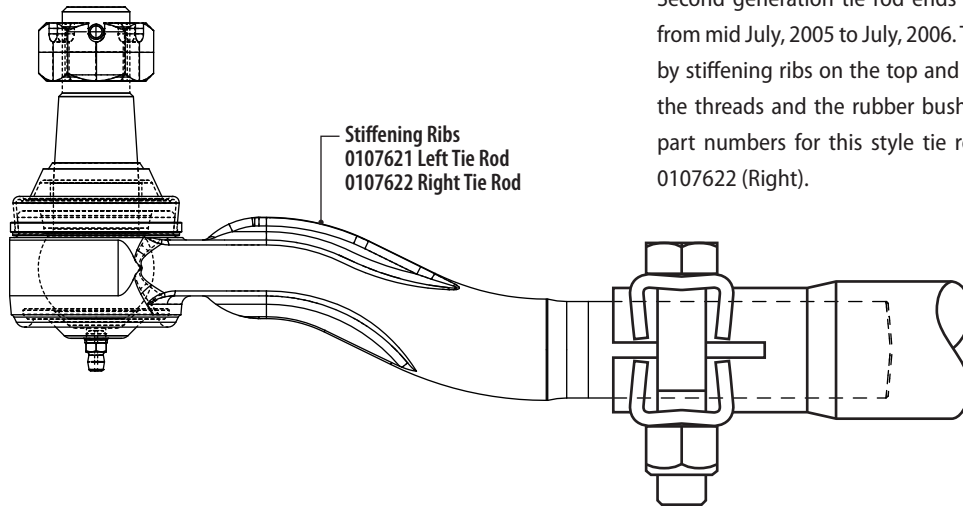
Second Generation Tie Rod Ends

Second generation tie rod ends were used on Blue Bird Visions from mid July, 2005 to July, 2006. This tie rod end can be identified by stiffening ribs on the top and bottom of the casting between the threads and the rubber bushing. The Blue Bird replacement part numbers for this style tie rod end are 0107621 (Left) and 0107622 (Right).

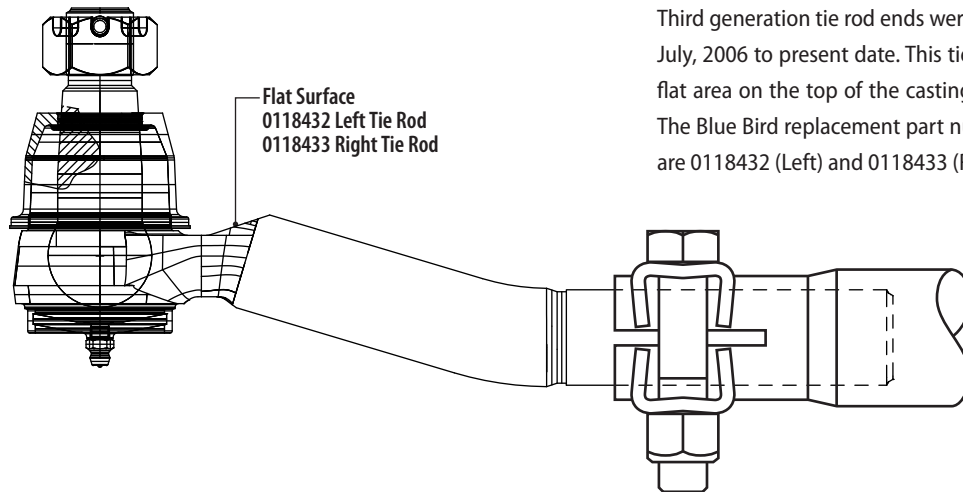
Third Generation Tie Rod Ends

Third generation tie rod ends were used on Blue Bird Visions from July, 2006 to present date. This tie rod end can be identified by a flat area on the top of the casting very near the rubber bushing. The Blue Bird replacement part numbers for this style tie rod end are 0118432 (Left) and 0118433 (Right).

The tie rod ends for the Second and Third Generations are interchangeable even though visually they are different shapes and are from different manufacturers.
