SERVICE INFORMATION BULLETIN

Subject:
THE MATERIAL OF THE ROCKER ARM SUPPORT BOLT AND CAMSHAFT BEARING CAP BOLT WAS CHANGED ON THE J05D ENGINE

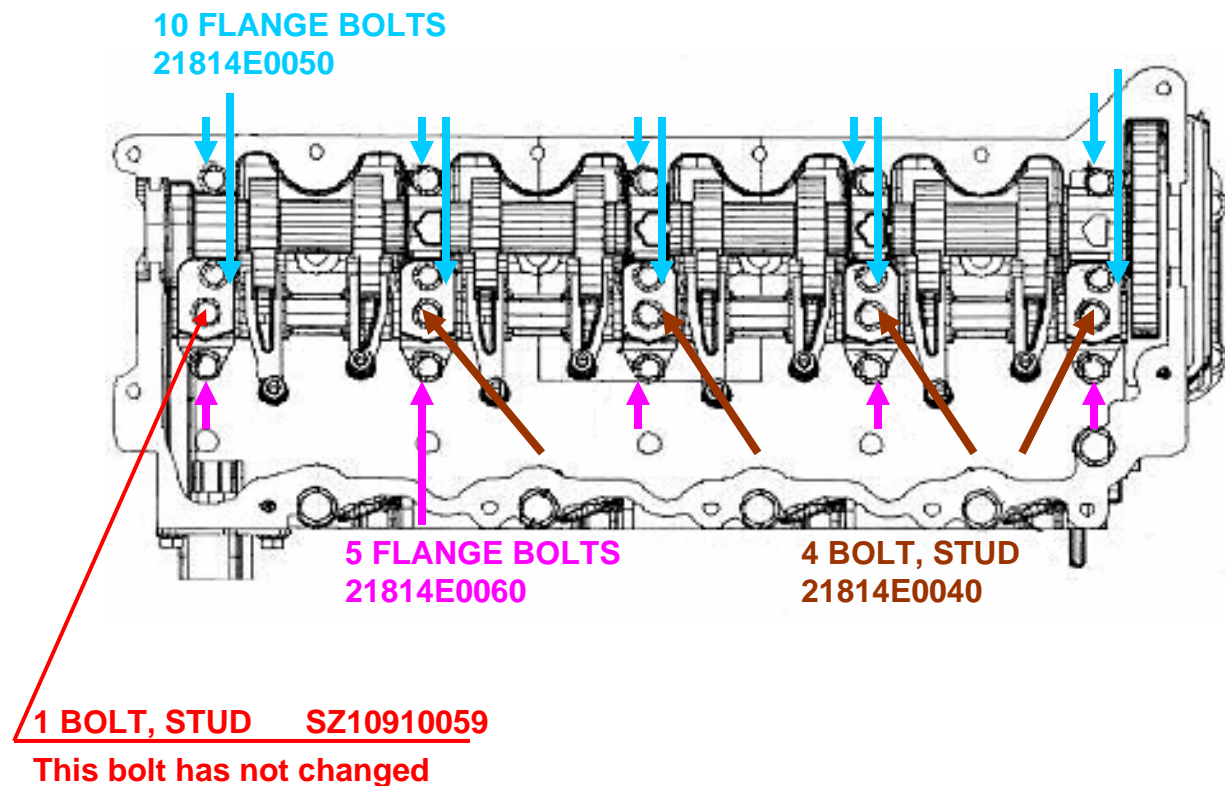
The document is to inform the dealers about the change in material and tightening torque of the rocker arm support bolts and camshaft bearing cap bolts.

The material and the tightening torque of the rocker arm support bolts and the camshaft bearing cap bolts will be changed as the illustration shows below.

DESCRIPTION	CURRENT	NEW
DIAMETER X PITCH	M8 X 1.25	M8 X 1.25
TIGHTNING TORQUE	21 lbf.ft. (28 Nm)	27 lbf.ft. (36 Nm)

SERVICE NOTE: Before installing bolts clean out and verify that all threaded holes in the cylinder head are clean of any oil and debris. Which may otherwise affect their ability of obtaining the proper torque.
