Bulletin No.: 03-07-30-011E

# Service Bulletin

**Subject:** Allison Transmission Delayed Engagement, Cold Hesitation, Malfunction Indicator Lamp (MIL) Illuminated, DTCs P0701, P1709, P1711, P1713, P0841, P0843, P0847, P0870, P0872, or P0875 (Replace Torque Converter Relief Spring, Transmission Fluid Indicator and Lube Regulator Spring in Front Support)

**Models:** 2001–2003 Chevrolet Silverado 2500/3500 Series  
 2001–2003 GMC Sierra 2500/3500 Series  
 with Allison® 1000 Series Automatic Transmission (RPO M74)  
 Built Prior to Indianapolis Plant Serial Number 6310234829, Baltimore Plant  
 Serial Number 6320154492 and Remanufactured Transmission Serial  
 Number 9620011913

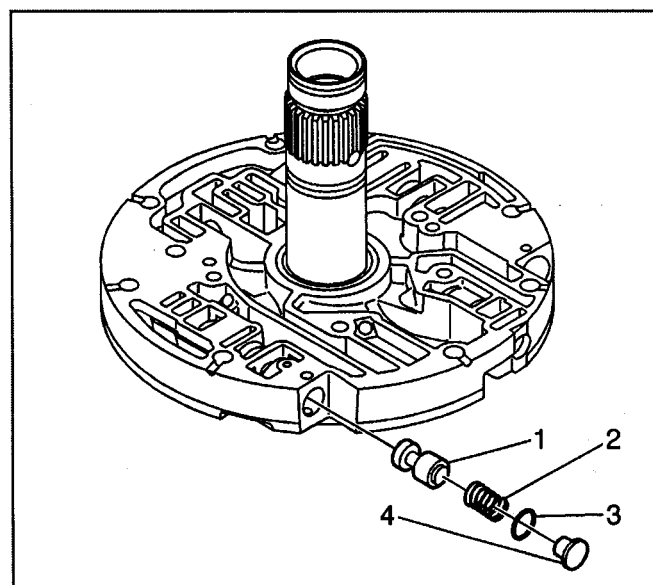
1213545

**Important:** If the lube regulator stop O-ring seal is cut or omitted, the transmission will not prime.

13. Install the lube regulator valve (1) as shown above.
14. Install the lube regulator spring (2) (blue in color, free length 31.43 mm (1.237 in)).

15. Install a new O-ring seal (3) on the lube regulator spring stop (4). Dip the lube regulator spring stop in transmission fluid. Install the stop into the bore. Use the J 43773 tool to compress the spring. Install the retaining pin. Ensure that the pin is below the surface of the support and the stop is positioned against the stop pin.
