Subject: TIB 45-32, Oil Fill Support Bracket Campaign

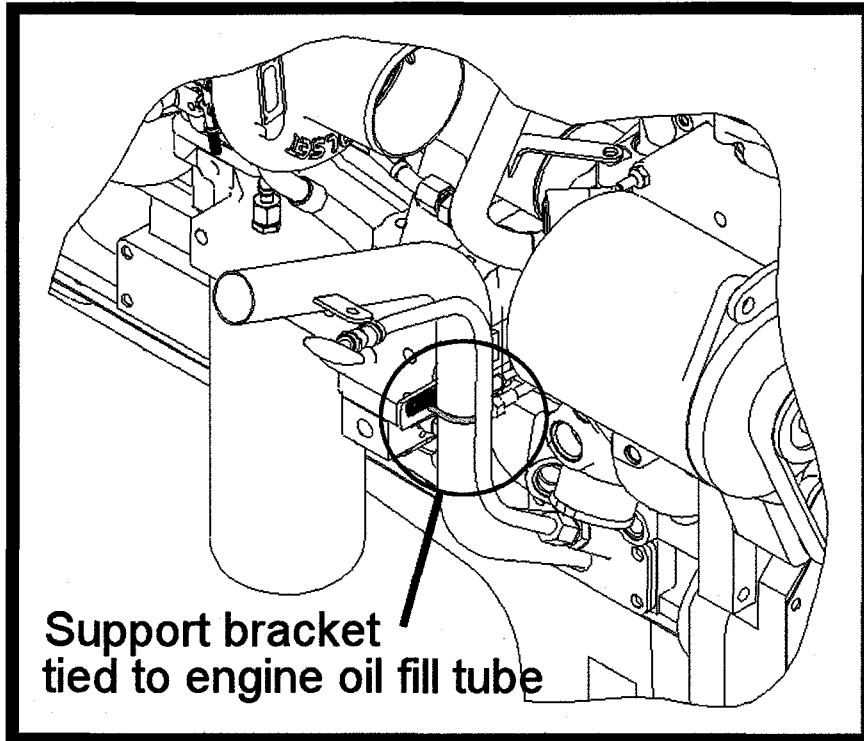
Illustration of support bracket and clamp on engine oil fill tube

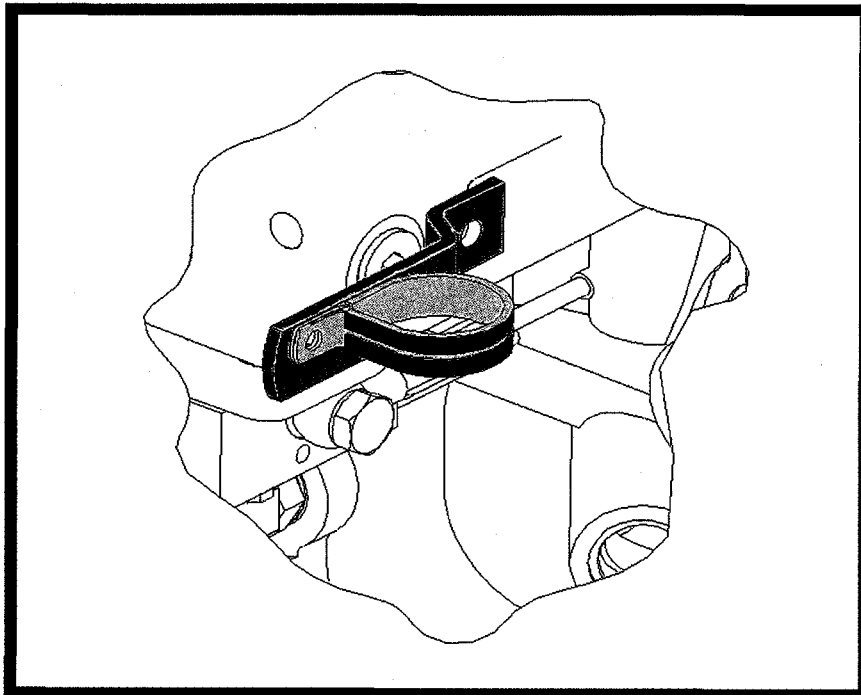
Close-up of support bracket and clamp (oil fill tube not shown)
