Jumper Cable Routing

MODELS AFFECTED: 2008-2009 BBCV Visions w/ 2007 Cat Engines

S08MY SERVICE BULLETIN

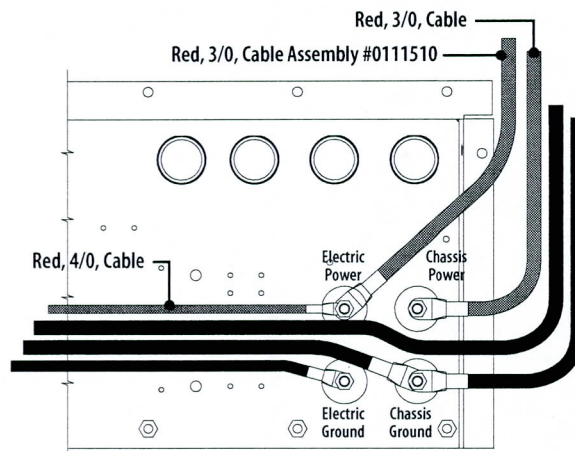
Engine may experience shut down after initial start up.

Incorrect Routing

Relocate positive jumper cable from Electrical Power Stud to Chassis Power Stud.

- 4** The lower end of Cable Assembly 0111510 should be attached to the Chassis Power Stud. If the cable is in this location, no further action required. If the lower cable end is attached to the Electrical Power Stud, remove it and attach it to the Chassis Power Stud.
- 5** Tighten both stud nuts to 11- 15 ft-lbs and apply a corrosion protection such as red glyptal.

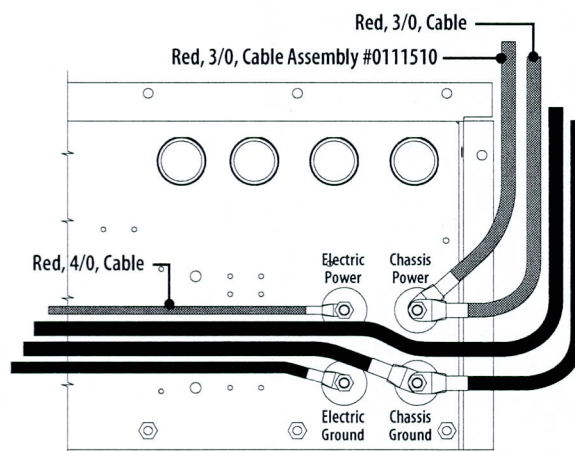
Correct Routing
