Subject: TIB 02-107, T800 Metton Hood Repair Campaign

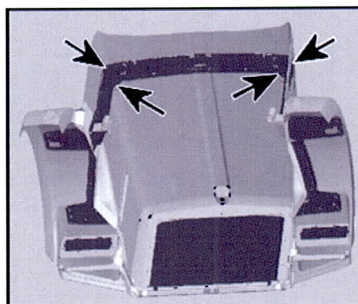
Kenworth has identified that hoods on some T800 chassis manufactured between 12/15/04 and 01/29/07 have experienced hood reinforcement channel cracking due to unique, harsh service conditions. This hood reinforcement channel cracking has sometimes exhibited hood exterior surface cracks as depicted in the following drawing (drawing shows underside hood reinforcement channel and points to radius area).

This repair applies only to failures evidenced by hood surface cracking at the reinforcement channel radius; it does not apply to any other kind of hood damage.

Kenworth has developed a specific repair for such failures, and if your chassis' hood exhibits this failure mode, Kenworth will extend warranty coverage to October 30, 2010.

If your chassis' hood exhibits the failure described, make an appointment for repair with any Kenworth dealer. To find your nearest Kenworth dealer, visit Dealer Locator at the internet website [www.Kenworth.com](http://www.Kenworth.com). When contacting your selected Kenworth dealer, refer to TIB 02-107 and the chassis listed on this letter. A scheduled appointment will take approximately eight hours and there will be no charge to you for work performed.
