Warm Air from HVAC Vents with A/C ON - DTC B1479

Applicability

YEAR(S)	MODEL(S)	ADDITIONAL INFORMATION
2010 – 2011	RX350

Some RX 350 vehicles may exhibit a condition where the HVAC system intermittently blows warm air from the vents with the A/C ON.

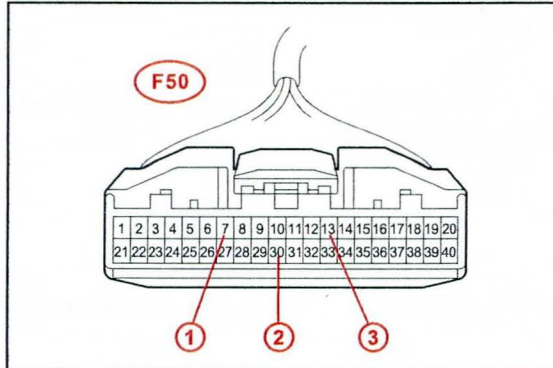
Figure 1. Front View of Wire Harness Connector (to A/C Amplifier)

1	FLOQ
2	S5-1
3	SG-2

TESTER CONNECTION	CONDITION	SPECIFIED CONDITION
F50-7 (FLOQ) - D10-3 (QUFL)	Always	Below 1 Ω
F50-13 (SG-2) - D10-2 (SGFL)	Always	Below 1 Ω
F50-30 (S5-1) - D10-1 (S5FL)	Always	Below 1 Ω
F50-7 (FLOQ) - Body Ground	Always	10 k Ω or Higher
F50-13 (SG-2) - Body Ground	Always	10 k Ω or Higher
F50-30 (S5-1) - Body Ground	Always	10 k Ω or Higher

- If any of the harness resistance tests fail, this bulletin does NOT apply. Repair or replace the harness and go to step 5.
- If all tests are within specifications, proceed to step 4.

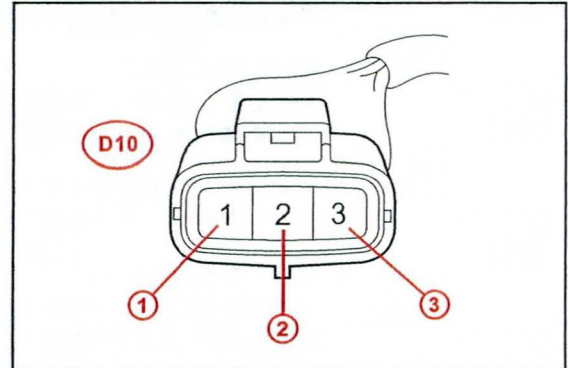
Figure 2. Front View of Wire Harness Connector (to A/C Compressor [A/C Mass Flow Sensor])

1	S5FL
2	SGFL
3	QUFL
