You will find enclosed a copy of Service Bulletin S10RB regarding the skirt mounted luggage boxes on certain 2009 model year Blue Bird All American and Vision model bus(es).

# Luggage Box Rework

**MODELS AFFECTED:** 2009 BBCV, A3FE, and A3RE with Skirt Mounted Luggage Boxes

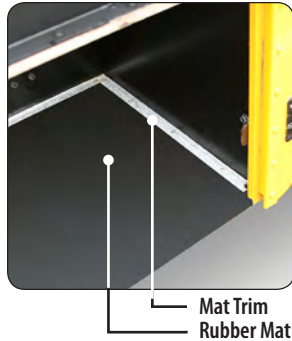
On some affected buses, spot welds on the luggage box bottom panel reinforcement channels and crossmembers may break. Luggage boxes which are tack welded have been determined to be sufficient.

5.1 Open the Luggage Box. Remove the interior trim pieces which surround the rubber mat. Remove the rubber mat.

5.2 On the underside of the Luggage Box, drill a pair of 17/64" hole, one on each crossmember flange, at the center of a crossmember's length. Drill through the crossmember and the floor of the Luggage Box. Similarly Drill additional pairs of holes at 8" increments toward each end of the crossmember.

5.3 On the underside of the Luggage Box, drill a single 17/64" hole at the center of a reinforcement channel's length. Drill through the reinforcement channel and the floor of the Luggage Box. Similarly drill additional holes at 6" increments toward each end of the reinforcement channel.

5.4 Working from the inside of the Luggage Box, install a repair rivet (01854397) at each hole drilled in steps 5.2 and 5.3.
