BLUE BIRD

# GM 8.1 Knock Sensor

MODELS AFFECTED: 2009 & 2010 Propane Visions

S10RN

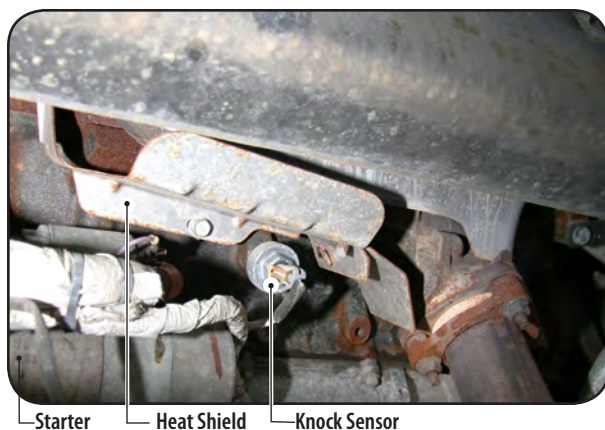
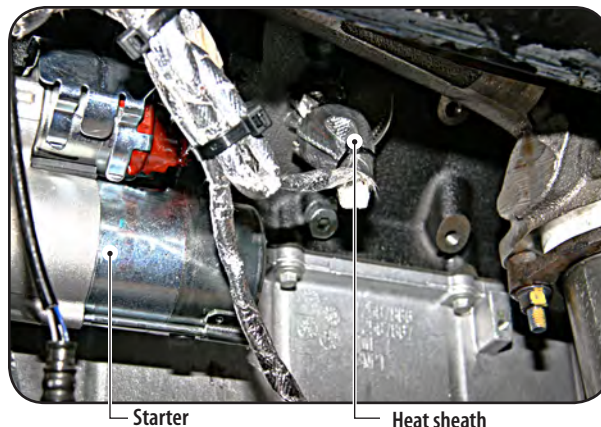
**2** Locate and inspect knock sensor. Sensor is located on the right side of the engine block, above and forward of the starter and below the exhaust manifold.

- If either heat shield or heat sheath is present, no action is needed; close and latch engine hood and return bus to service.
- If neither heat shield nor heat sheath is present, proceed to next step.
