BLUE BIRD

CSC-10043404-4516

Models Affected: 2010-2011 All American (D3RE) with Cummins ISC Engines

Charge air cooler tube support bracket may fail.

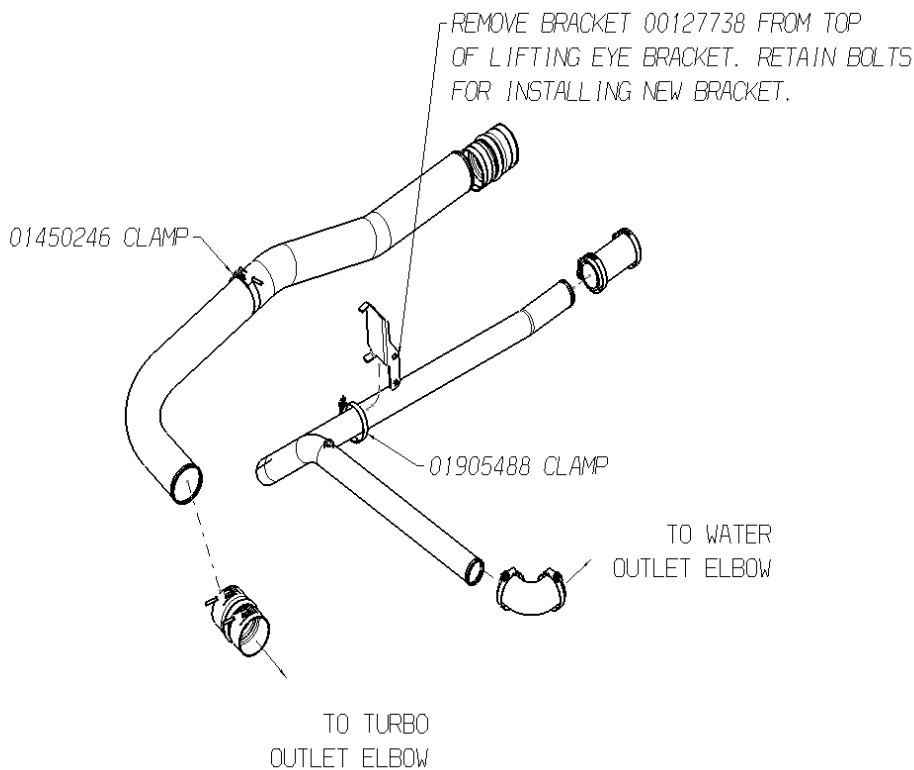
1. Park the bus on a level surface, apply parking brakes, turn off engine and remove keys. Chock wheels.
2. Remove existing charged air cooling tube support bracket, part number 00127738, and the related clamps per diagram below and discard. Retain fasteners to engine for use with new bracket.
