## Model series 221 Hybrid : Engine start/stop / engine starts up at random or 12 V on-board electrical system voltage too low

| Topic number | LI54.10-P-049241 |
| Design group | 54.10 Battery, voltage supply, voltage converter |

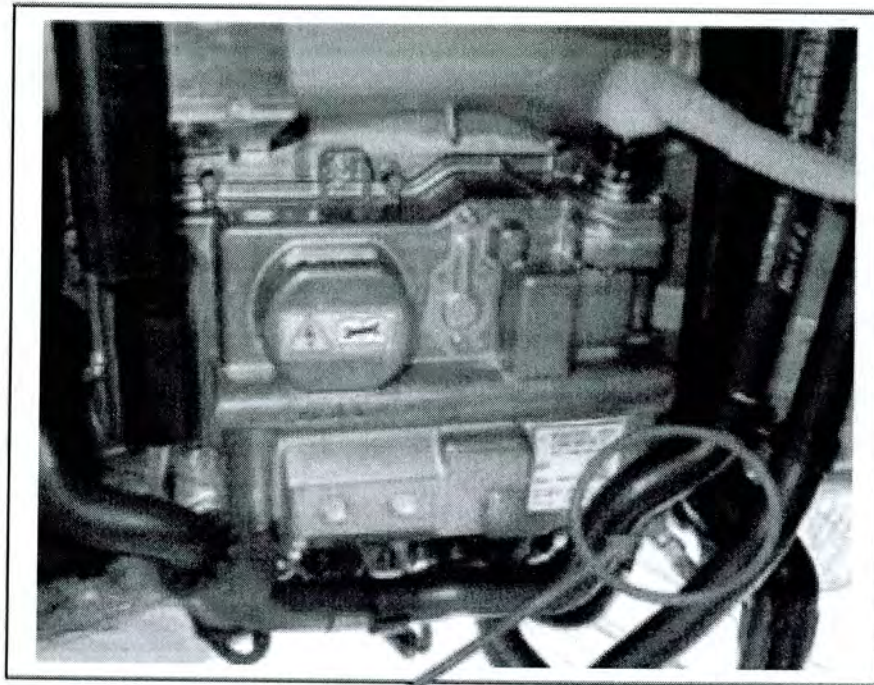
| Attachments | |
|---|---|
| Bild Masseanschluss Spannungswandler unten rechts.pdf | Picture - Voltage converter bottom right |

1. The contact surface of the ground line on the housing of the DC/DC converter is oxidized.
2. The ground point on the longitudinal member in the right front wheel arch is partially painted over.

1. Observe notes on working on the high-voltage on-board electrical system.
2. Perform a power disconnect of the high-voltage on-board electrical system.
3. Remove the ground line between the DC/DC converter and the vehicle body.
4. Rub down the contact surface of the ground line on the housing of the DC/DC converter with abrasive paper.
5. Clean paint/dirt off the contact surface for the ground line on the longitudinal member of the vehicle body.

Note: The eyelets of the ground cable are tin-plated and must therefore not be rubbed down!
