<b>Subject:</b>  <b>RATTLE NOISE FROM REAR STABILIZER</b>	<b>Bulletin No:</b> 02-005/12
	<b>Last Issued:</b> 10/18/2012

2010-2012 Mazda3 vehicles (except Mazdaspeed3) with VINs lower than JM1 BL \*\*\*\*\* 622215 (produced before March 01, 2012)

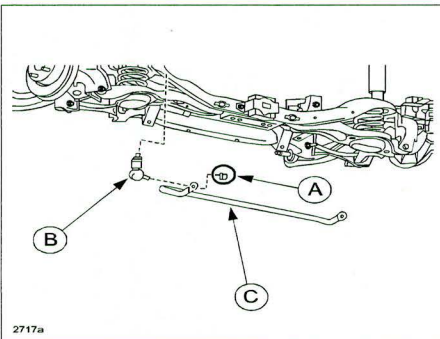
Some vehicles may exhibit a rattle type noise coming from the rear stabilizer when driving over a road bump. This noise may be caused by a loose rear stabilizer control link.

Old Style Locking Nut	New Style Locking Nut

1. Verify customer concern.
2. Verify the rear stabilizer control link nut torque is below the 31.8 - 44.8 ft-lbf specification.
3. If loose, replace with new nuts (A). Refer to MS3 online or Workshop Manual (section 02-14 REAR STABILIZER REMOVAL/INSTALLATION).

**NOTE:** After removing the nuts, inspect the threads of the bolts. If wear exists, replace the control link.

<p style="font-size: small; margin-top: 5px;">2717a</p>	<div style="border: 1px solid black; padding: 5px; width: fit-content; margin: 0 auto;"> <p style="text-align: center; margin: 0;"><b>R</b></p> <p style="margin: 0;">43.1 - 60.8 N·m {4.4 - 6.2 kgf·m 31.8 - 44.8 ft·lbf}</p> </div>

<div style="border: 1px solid black; padding: 5px; width: fit-content; margin: 0 auto;"> <p style="margin: 0;">45.0 - 55.0 N·m {4.6 - 5.6 kgf·m 33.2 - 40.6 ft·lbf}</p> </div>
Item	Description	
A	Locking Nut	
B	Rear Stabilizer Control Link	
C	Rear Stabilizer	
D	Old Style Locking Nut	
E	New Style Locking Nut With Identification Marks
