Rev2

Back Door Garnish Loose or Broken

YEAR(S)	MODEL(S)	ADDITIONAL INFORMATION	
2005 – 2010	tC	Plant Code(s): 0 WMI(s): JTK

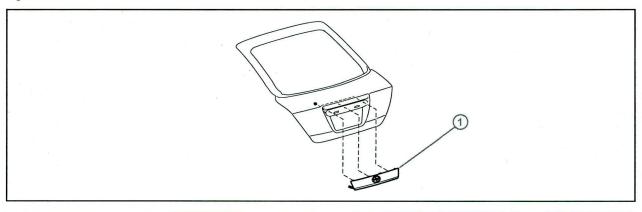
Figure 1.

Some 2005 - 2010 model year tC vehicles may exhibit a condition where the back door garnish becomes loose, and in some cases continued usage of the loose garnish may result in breakage. Please follow the procedure contained in this bulletin, which supplements the Repair Manual, to replace the back door garnish if it is loose or broken.

1 Back Door Garnish Sub-assembly Outside

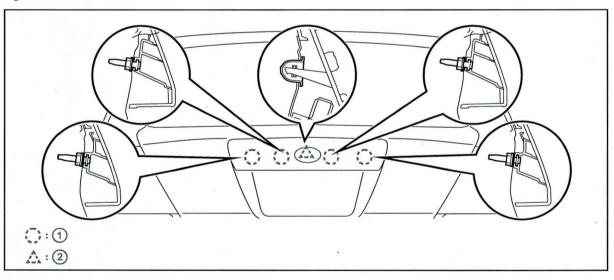
Figure 6.

1 Nuts

2 Clip

4. Remove the Back Door Outside Garnish Sub-assembly.

- A. Remove the 4 nuts.
- B. Detach the clip and disconnect the connector. Then remove the garnish.
