Reference	SSM46477
Models	LR2 / L359
Title	Freelander 2 Rear Differential Noise with reference to LTB00342
Category	Driveline
Last modified	25-Nov-2010 00:00:00
Symptom	509000 Axle Concerns
Attachments	Haldex GEN3 & GEN4 .pdf (Haldex GEN3 & GEN4 .pdf)
Content	<p><u>Issue:</u></p> <p>Excessive rumble/humming noise or high pitched whine coming from the rear of the vehicle</p> <p><u>Cause:</u></p> <p>Root cause, Pinion Tail Bearing spalling caused by subsurface material deformation. Cause of subsurface deformation is static overload.</p> <p><u>Action:</u></p> <p>For reported concerns where LTB00342 (Rear Differential Lower Level Repair) has been carried out or if a Rear differential is replaced:-</p> <p>Please be aware that a software update has been made available to help prevent premature pinion bearing failure in the future. This update should only be applied to the Haldex Coupling control module if the lower level pinion bearing repair has been carried out or if the rear differential assembly has been replaced.</p> <p>Note ! This software is only available for Generation 4 Haldex couplings which were fitted from Start of 2009 MY vehicle manufacture. A number of Vehicles built befo

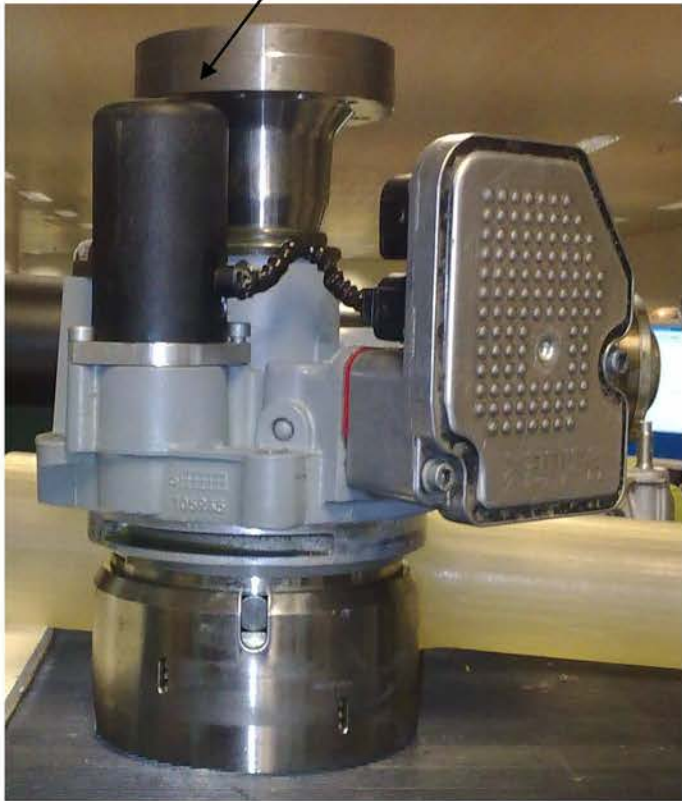
GEN3

Pump Assembly Black

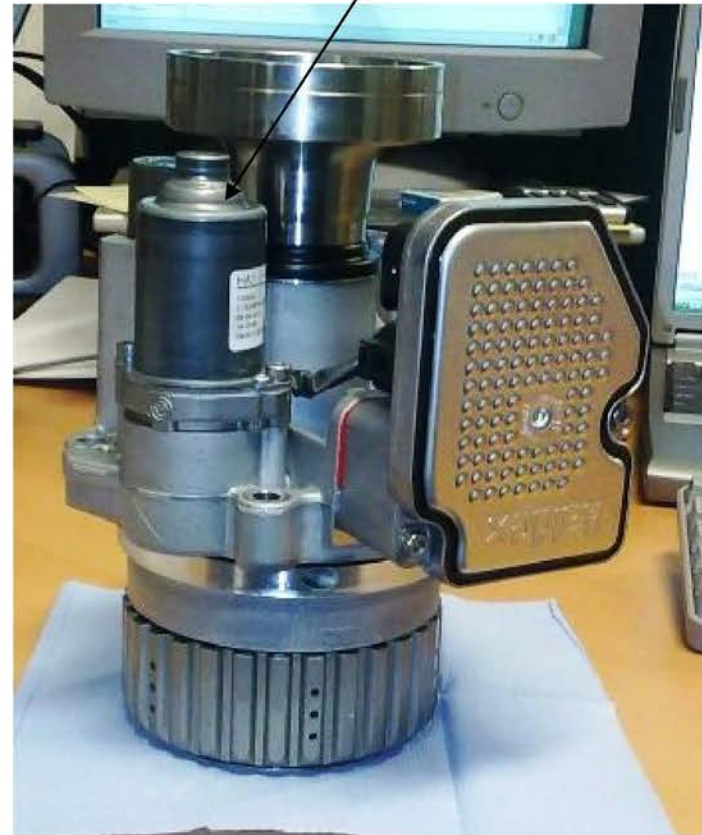
GEN4

Pump Assembly Silver
