CSC-10040386-2354

Subject: E033, Campaign to verify coolant filter torque

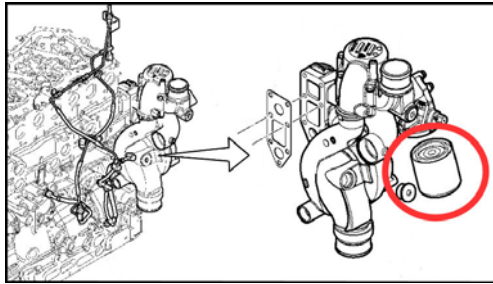
Kenworth has identified that some vehicles may have been manufactured with inadequate torque applied to the engine coolant filter. The vehicle listed by VIN on this letter is part of the potentially affected population and Kenworth would like the opportunity to inspect and take corrective action as appropriate. Left uncorrected, inadequate filter torque may result in the loss of coolant resulting in potential engine overheating.

Location of coolant filter depicted

Proper torque can be achieved by hand tightening the filter in the clockwise direction an additional $\frac{1}{2}$ to $\frac{3}{4}$ revolutions beyond the snug position (loosened counter clockwise to the point of coolant weeping).
