# Recall Campaign

December 2011  
FL609A  
NHTSA #11V-330  
Transport Canada #11-236

## Copy of Notice to Owners Subject: Starter Cable Isolator Bolts

### Subject: Starter Cable Isolator Bolts

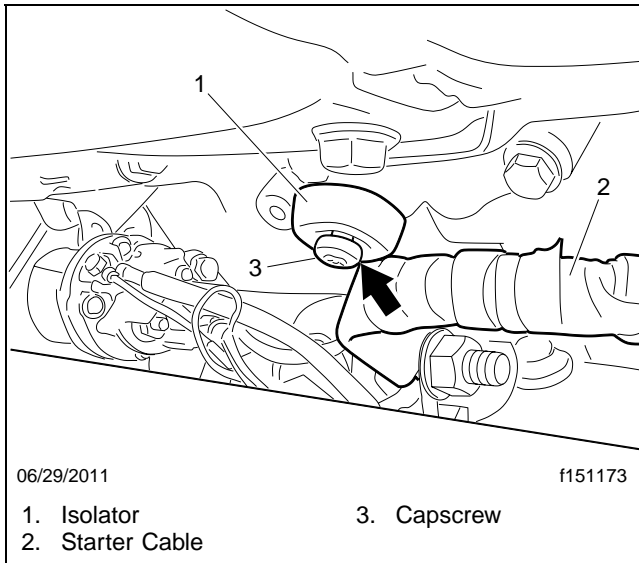
**Fig. 1, Installation that Requires Replacement**

On some vehicles equipped with a Detroit Diesel DD15 or DD16 engine, the bolt attaching a rubber isolator to a support bracket may become loose and back out, potentially contacting an un-fused starter cable and creating a short circuit. A short circuit between an un-fused starter cable and chassis ground could result in a vehicle fire.

4. Remove the capscrew, washer, and isolator from the side of the engine, then discard them. See **Fig. 1**.
