# Voluntary Recall Campaign

**Subject: Inspection and Replacement of Turbocharger - J08E**

**Bulletin: RCB-003-11**

**Affected Models: Certain 2008 – 2010 MY ND8J, NE8J, NJ8J, NV8J models equipped with a J08E engine**

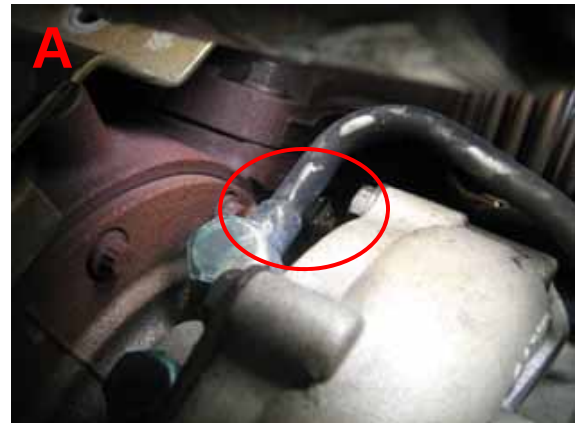
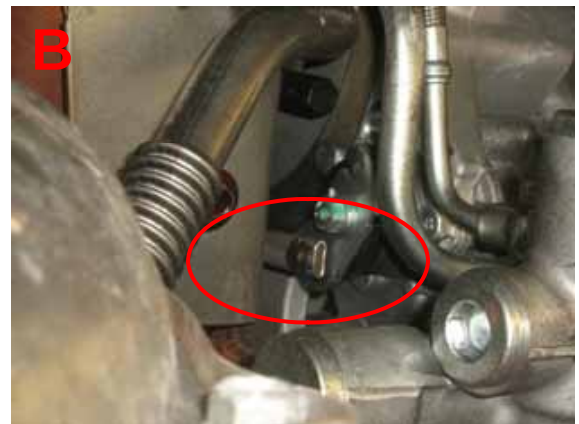
**11.** Lubricate the VNT turbocharger upper (A) and lower (B) link rod pivots with the aerosol “Loctite Nickel Anti-Seize”, part number 51286.

(iii) If either DTC’s P0045 / U1123 set again or the “VNT Actual Position” fails to follow the “Directed VNT Position”, replacement of the VNT turbocharger assembly will be required. Please continue to the “**Turbo Replacement Procedure**”. If the “VNT Actual Position” now successfully follows the “Directed VNT Position” and the DTC’s P0045 and/or P0045 U1123 do not reset, please continue to **STEP 12**.

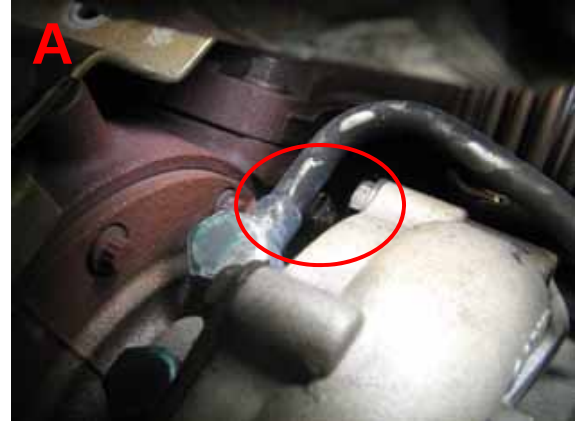
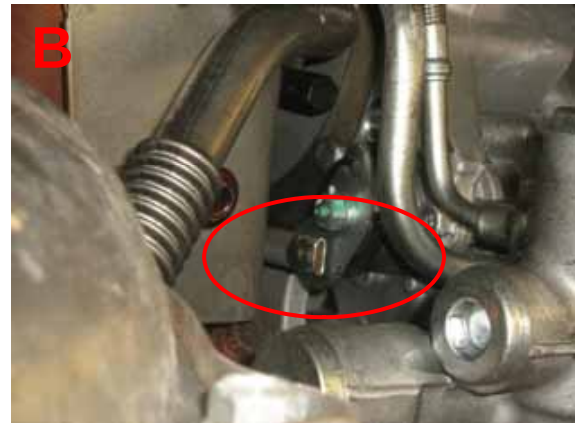
12. Lubricate the VNT turbocharger upper(A) and lower(B) link rod pivots with the aerosol “Loctite Nickel Anti-Seize”, part number 51286 and then cycle the VNT turbocharger 10 times to allow the “Loctite Nickel Anti-Seize” to penetrate and work into the VNT pivot and pivot rod joint. With no current failures found of the VNT turbocharger, VNT turbocharger replacement **WILL NOT** be required at this time. The vehicle can be returned to the customer as no further service will be required.
